Interconnection of New Cold water channel with Existing Channel of Rihand Stage III

cold water from Helper cell through new channel to be done in the existing channel.

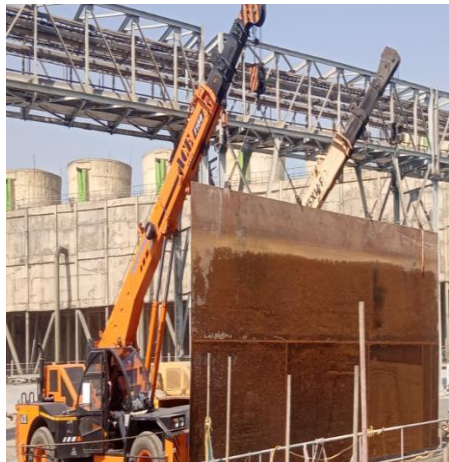
80 MT crane was deployed to lower the C section into the channel.

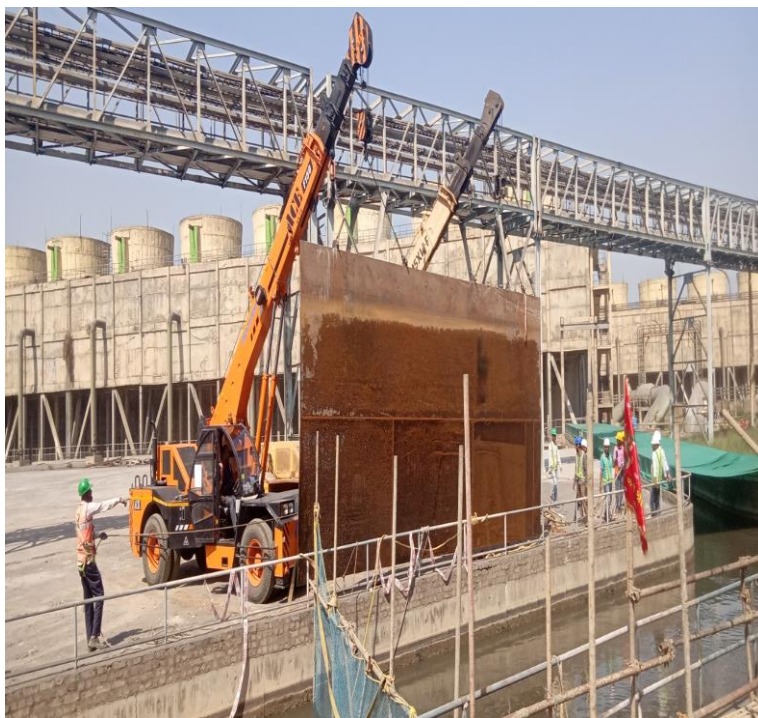
Fixing of 20 mm plate on the interconnection wall section.

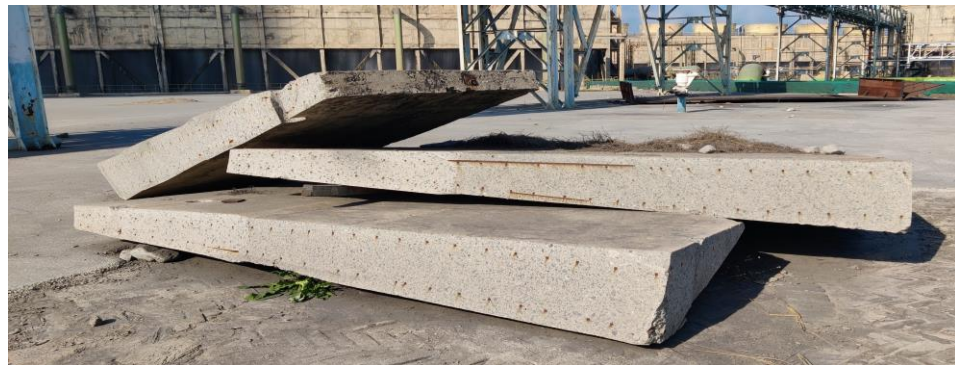
3rd wall panel cut and lifted
