**A CASE STUDY ON SHIP
UNLOADER
AT
MSTPP/BIFPCL
(Bangladesh)**

Project Name: Maitree Super Thermal Power Project (2 X 660 MW)

FAILURE ANALYSIS

HOLD DRUM

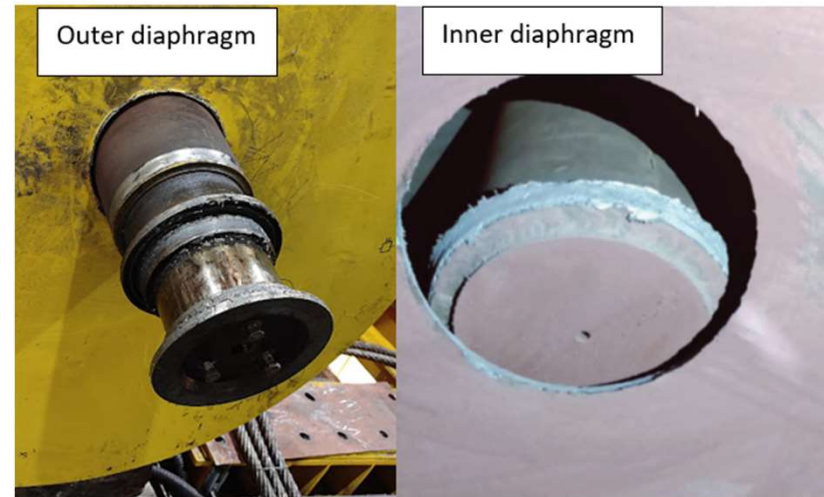
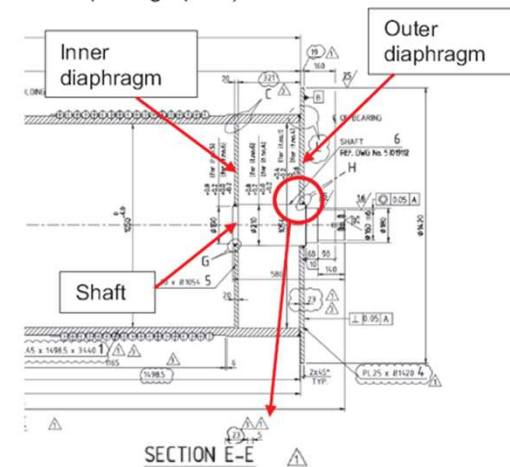
On 10.11.2022, SUL-3 was stopped on hearing abnormal sound from its hold drum. It was observed that NDE shaft of holding drum (1420 Dia. X 3380 Long) got detached from drum body.

Size of the holding drum: 1420 mm Dia. X 3380 mm Long.

Cause of Failure: NDE (Floating side) shaft got detached from Drum.

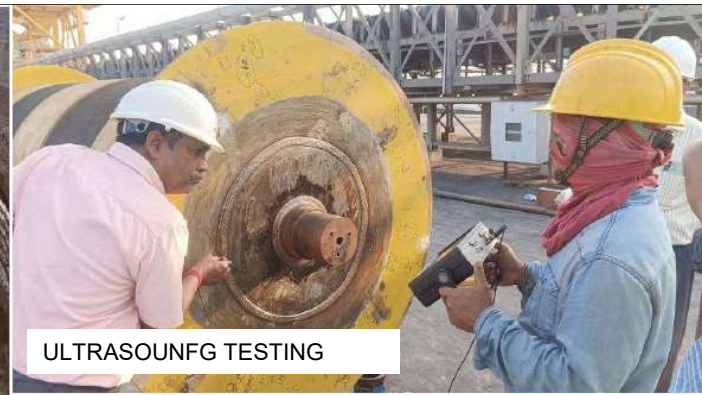
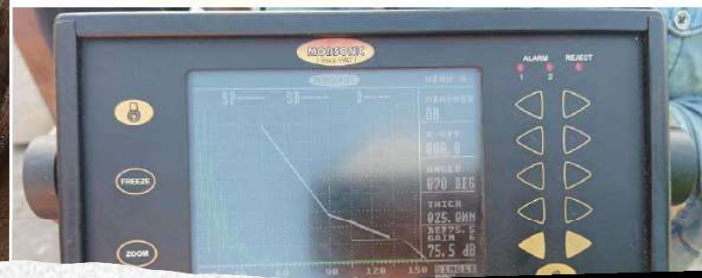
ULTRASOUNFG TESTING

DP was done during various stages of welding. DPT after 3 days of welding also found normal. After completion of entire welding work ultrasound testing was done to detect any welding defect.

During ultrasound, no peak touches DAC (Distance amplitude curve) line.

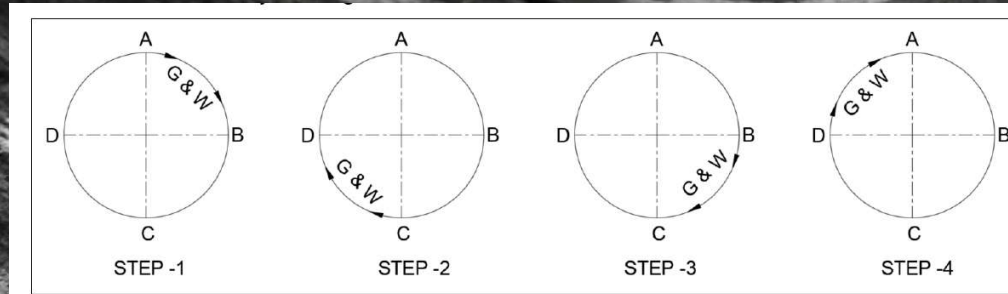
Category 2: Surface defect noticed during DP & UT :

Repairing of the crack to be done as per welding procedure

Weld metal shall be deposited in layers up to 90degree. Welding to be done opposite sides of shaft by rotating the drum.

Total weld metal deposited up to 17+ 5 mm leg size.

Welding to be done in one stretch
