A Comprehensive Analysis by PAUT of Stress Corrosion Cracking (SCC) in Austenitic Stainless Steel Super 304H & 347H Grade Tubes in Super critical thermal power plant

B C Roy , R K Jain , U. Srinivasa Rao , Aditya Kumar Gupta

IPS 2024, RAIPUR
Date : 13-15 Feb

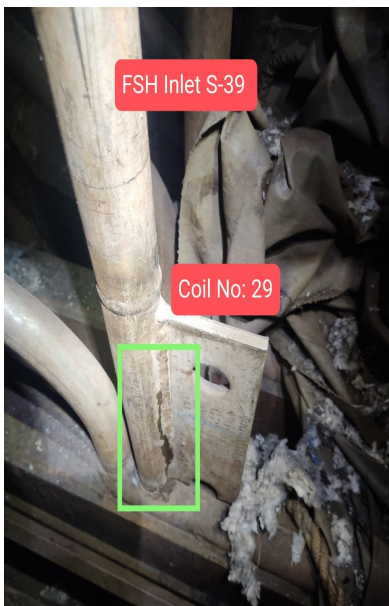
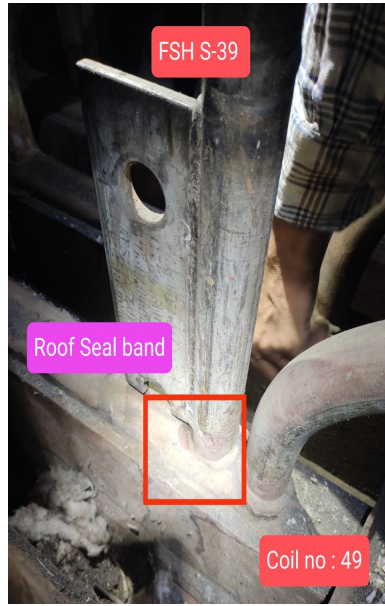
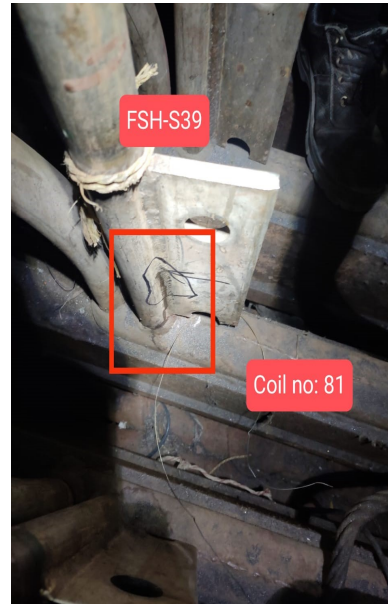
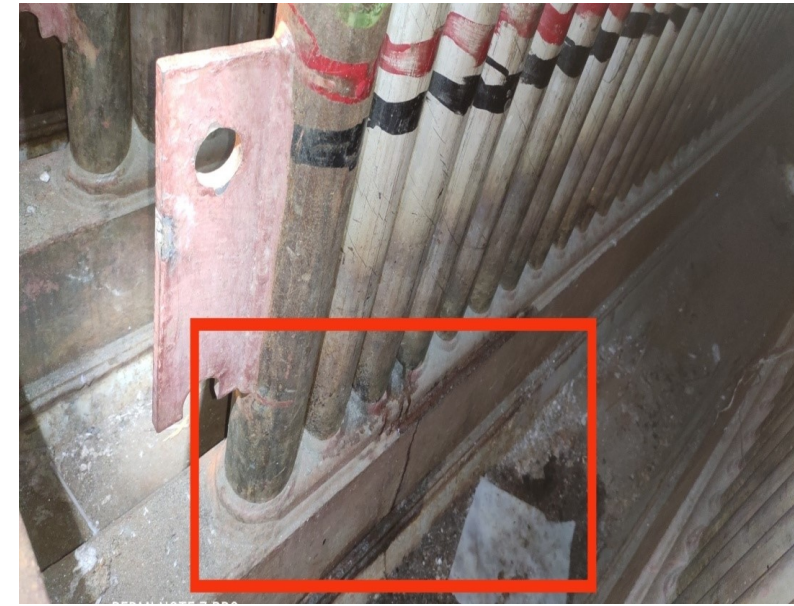
Seepages observed in Shop welded attachment lifting lug joints & Roof Seal band area in Finish Superheat (FSH) inlet Super 304H coils (S-39) of during 1st Hydrotest

Observed seepages in 29 tubes near SHOP WELDED Seal band joints of Finish Reheater (FRH) coils during 1st hydrotest

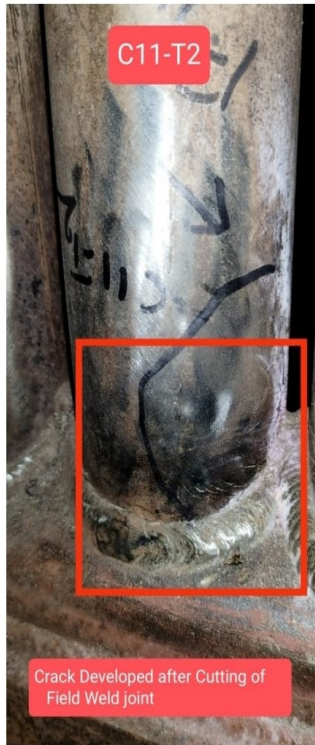
Crack Developed after Cutting of Field Weld joint

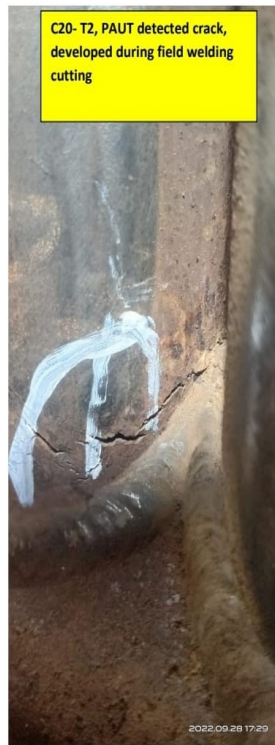
C20- T2, PAUT detected crack, developed during field welding cutting

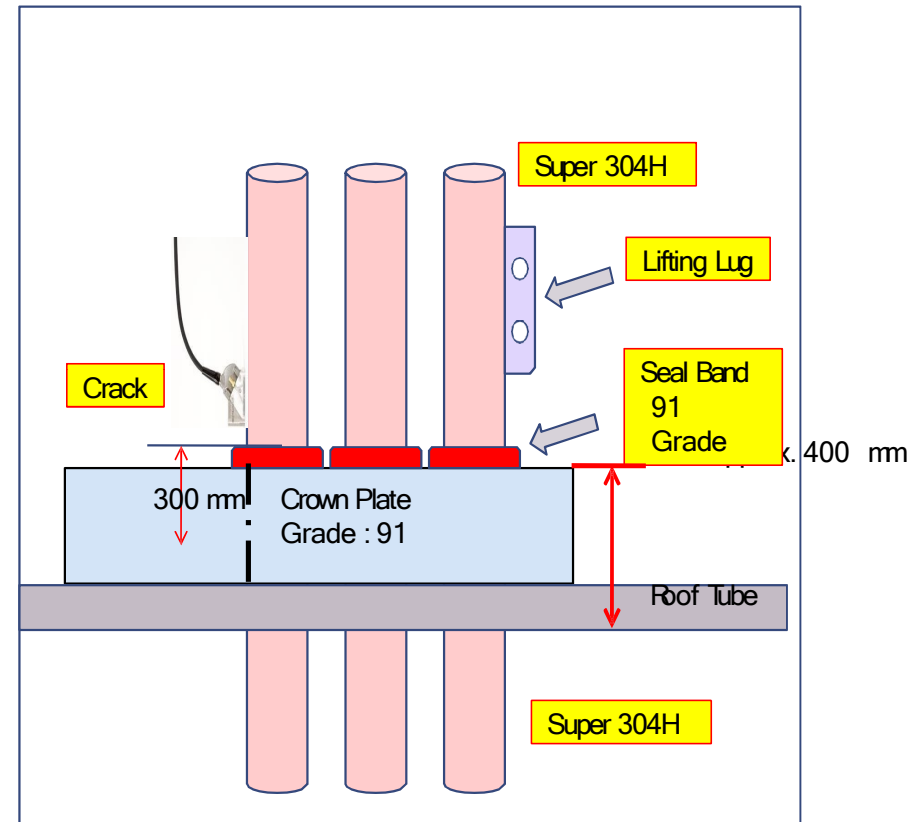
FRH coil tubes near Seal band weld lost it's ductility!

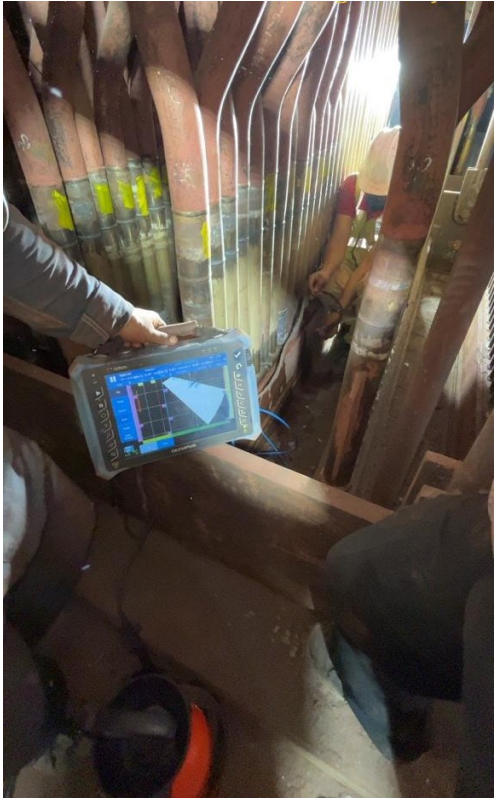
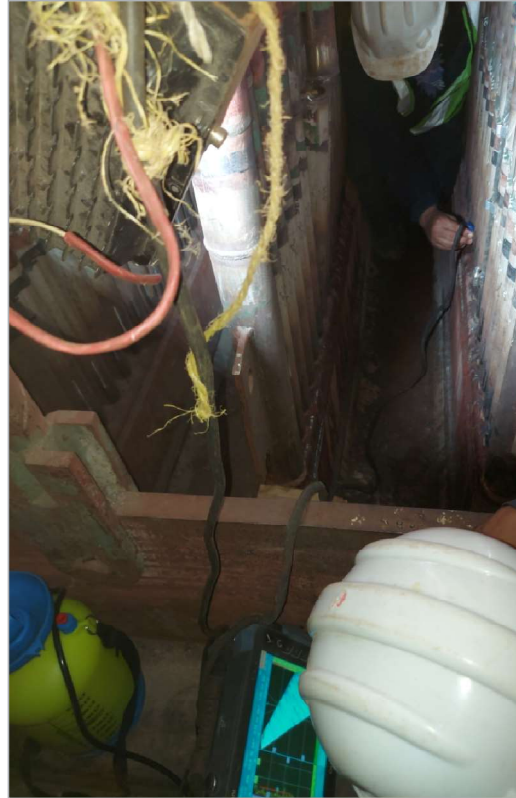
Visual examination & PAUT of FRH seal band area:

The weld joints and adjoining Heat Affected Zone (HAZ) were examined by Advanced NDE technique like Phased Array Ultrasonic Testing (PAUT) for detection of cracks on ID/OD of Super 304H tubes of FRH coils.

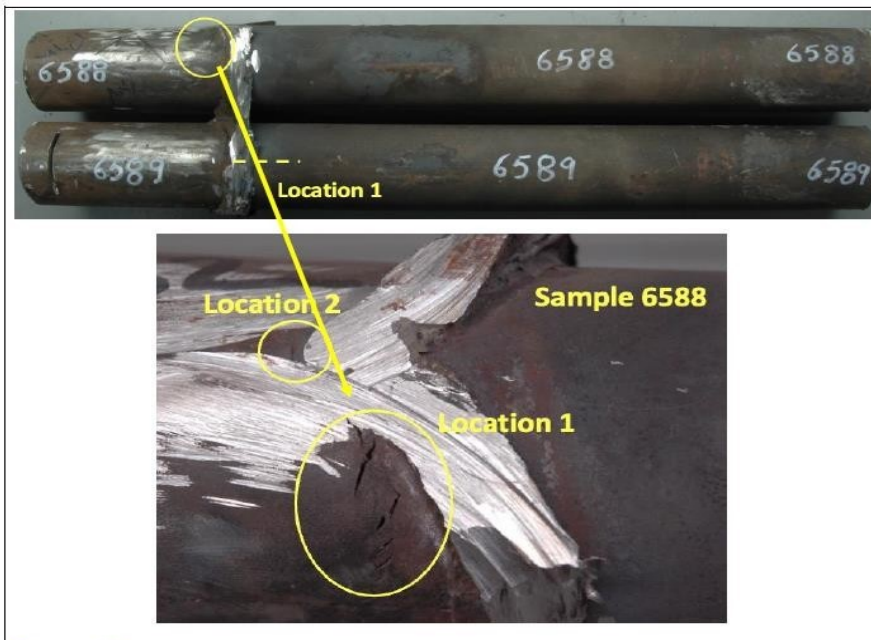
Figure -2

Photograph of as received final reheater tube (sample no 6588) showed cracking close to fillet seal weld (Location 1). Cracks also observed in the inaccessible zone between the tubes (Location 2).

Sample 6589 showed no visible cracks.

Intergranular cracking up to a depth of 3mm (tube thickness of 4mm), high hardness, sensitization upto 300mm and presence of Chloride deposit confirmed that the tubes failed due to **intergranular stress corrosion cracking**.

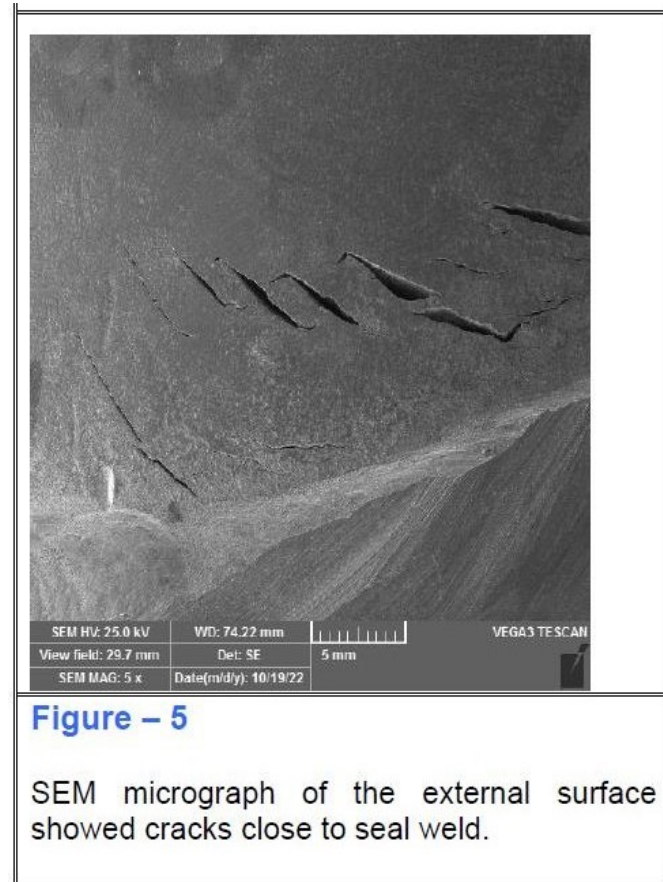
Figure - 5

SEM micrograph of the external surface showed cracks close to seal weld.

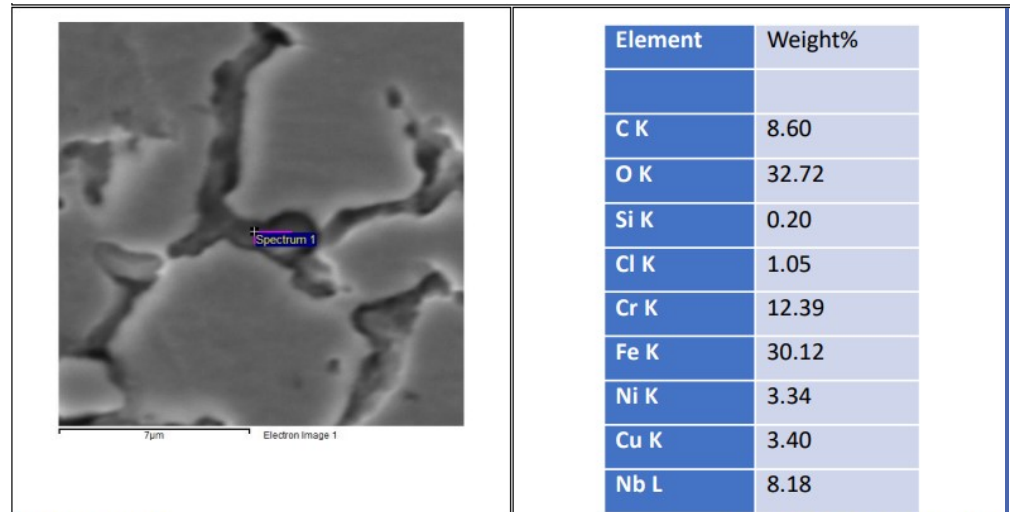
Figure – 27

Internal surface cracks

EDAX analysis at one of the *internal* surface crack locations showed presence of Cl.

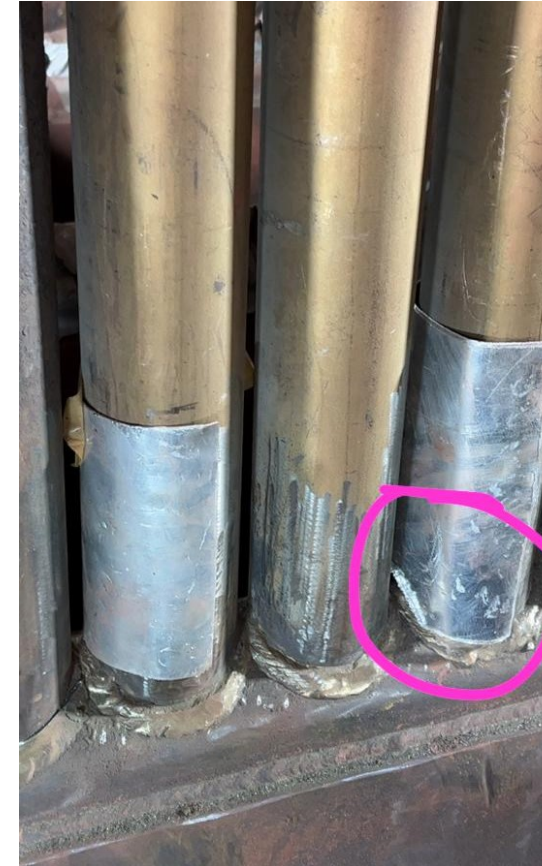
Cut-marks on the adjacent tubes

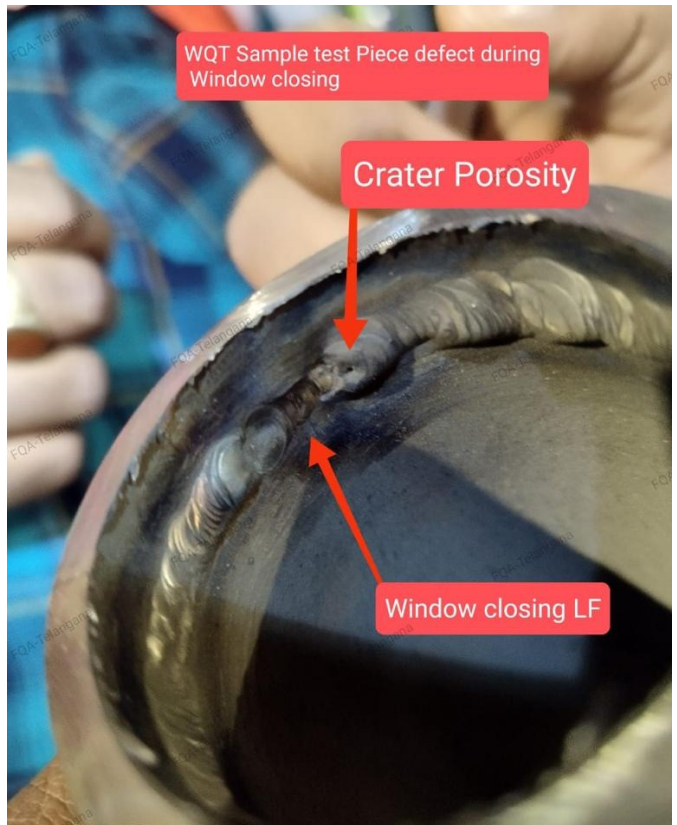
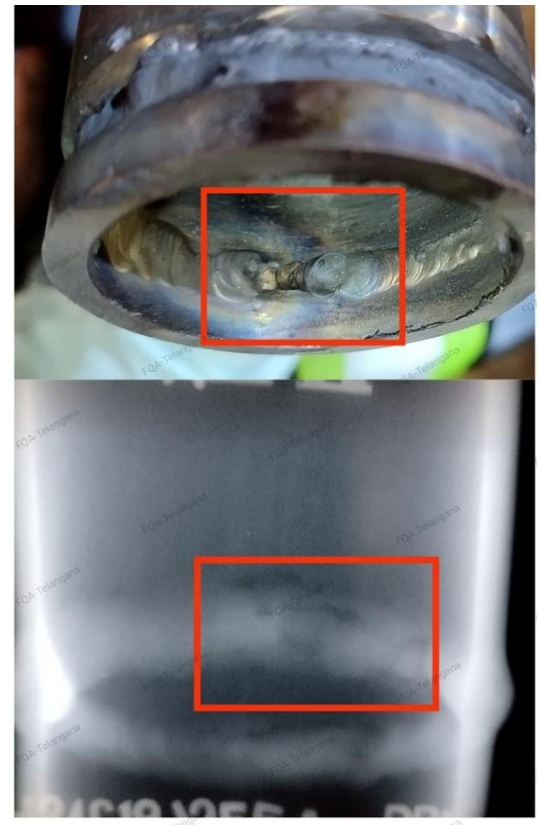
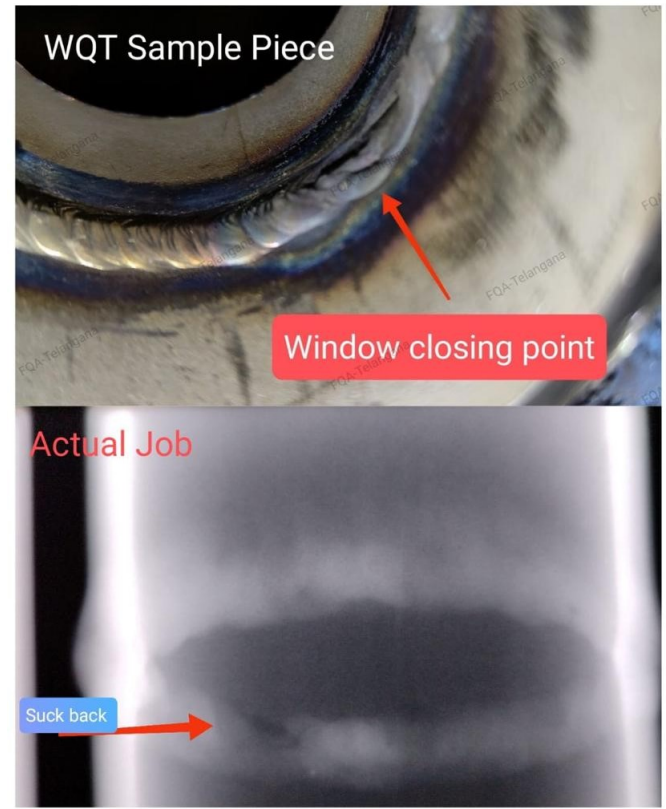
High % Repairs while closing the window of the Root welding

- 1. Using Full purge**
- 2. Welder Qualification in simulated condition**
- 3. Using sloping in hot pass near the root window & grinding before window closing**
- 4. Creating the opening in purge dam at the end**
- 5. Welding with medium speed to ensure the full penetration**
- 6. Daily monitoring of Welder performance & feedback to IBR welder by showing RT images**

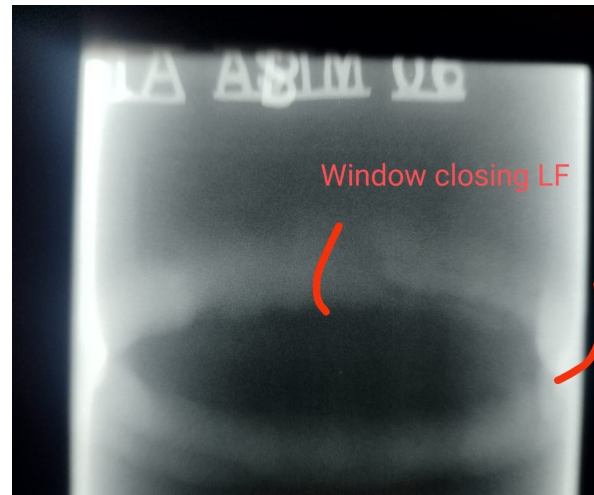
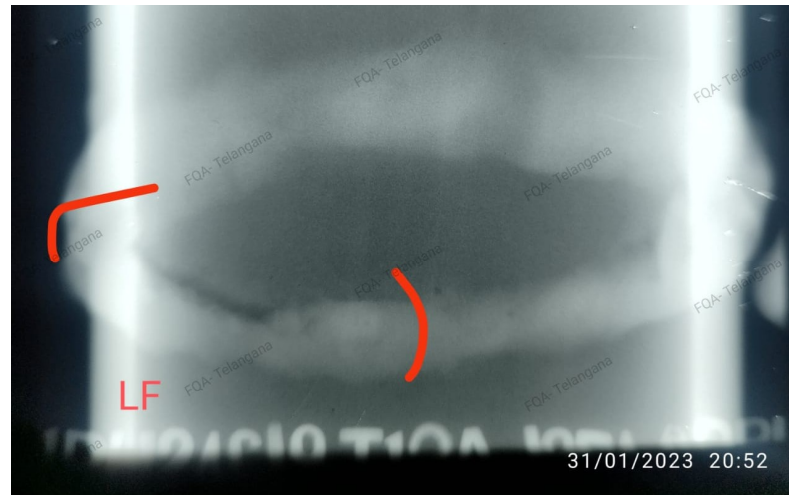
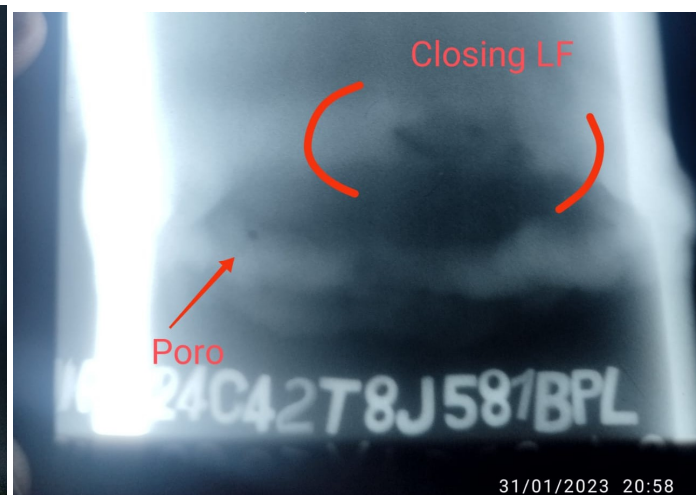
Radiograph images of defect joints

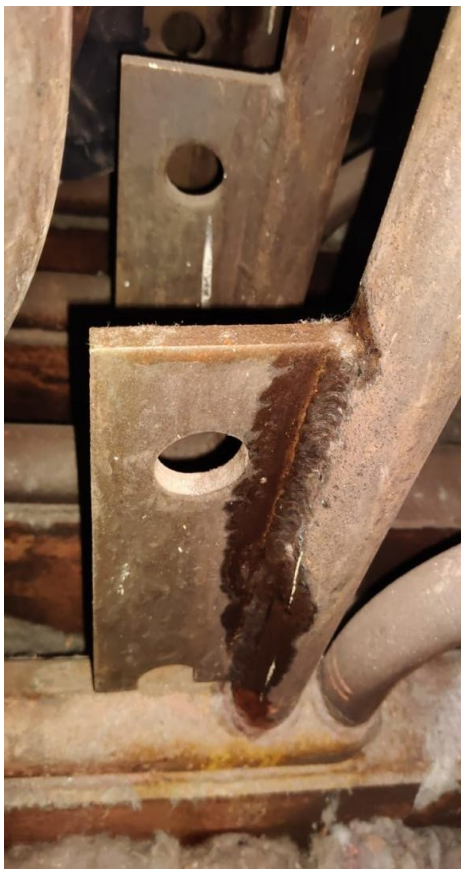
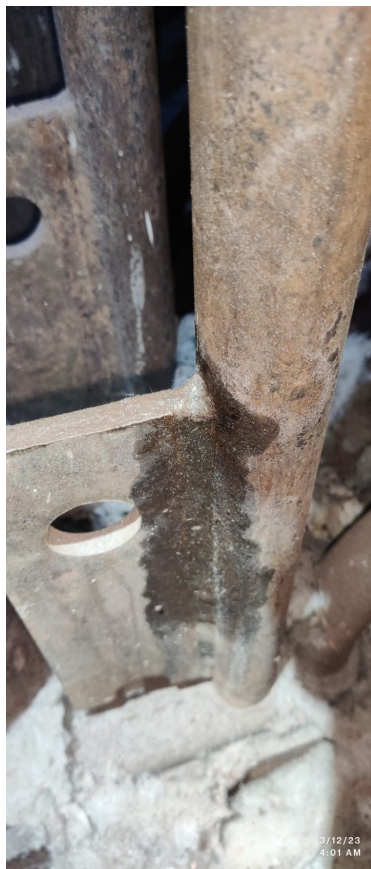
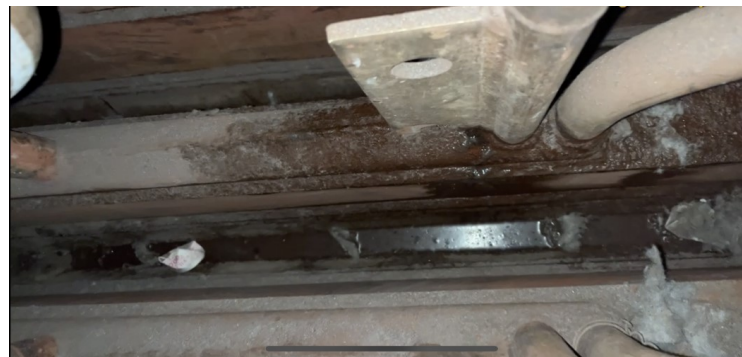
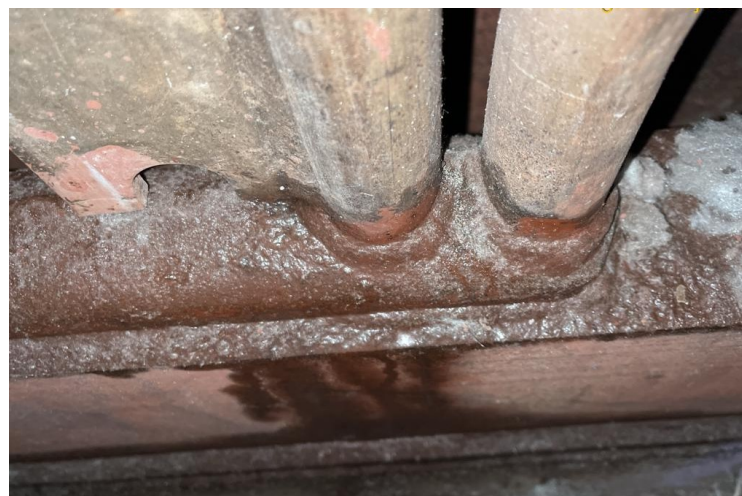
Seepages in Seal band & Lug plate in PSH & FSH coils

Seepage Observed in Superheater in Hydrotest done after Steam Blowing

Total no.of lug plate tubes to be replaced: **484 nos.**

Total no.of joints to be welded: 968 Butt joints + 484 fillet joints (Seal welds)

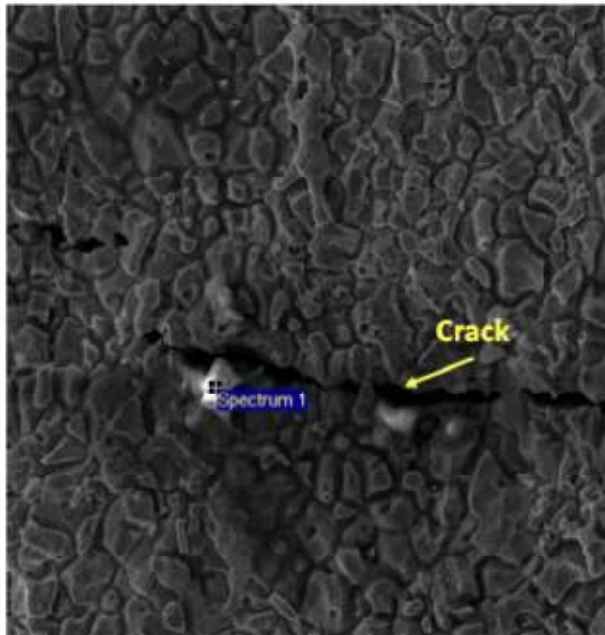
Figure – 11

- **Trans-granular cracking** (on internal surface below the weld of tube with lifting lug) and high hardness at failure indicate high residual stresses at the tube below the fillet weld.
- **Presence of Chloride in deposits at failure location** confirmed that the tube failed due to stress corrosion cracking (SCC).

At Failure

EDAX analysis at internal surface showed white colored deposit rich in Cl content at the crack.

SS tubes were chemically cleaned, passivated & examined for Chloride content by EDAX analysis before use
