## Retrofitment of SEALGUARD ASSEMBLY in WAGON TIPPLER for reliable operation of movable Side

### A case study of NTPC Kudgi

**PRESENTED BY :** HIMANSHU KR , DGM (FHMM) – Main Author  
Manish Kumar Sah , AGM ( FHMM) - Co - Author

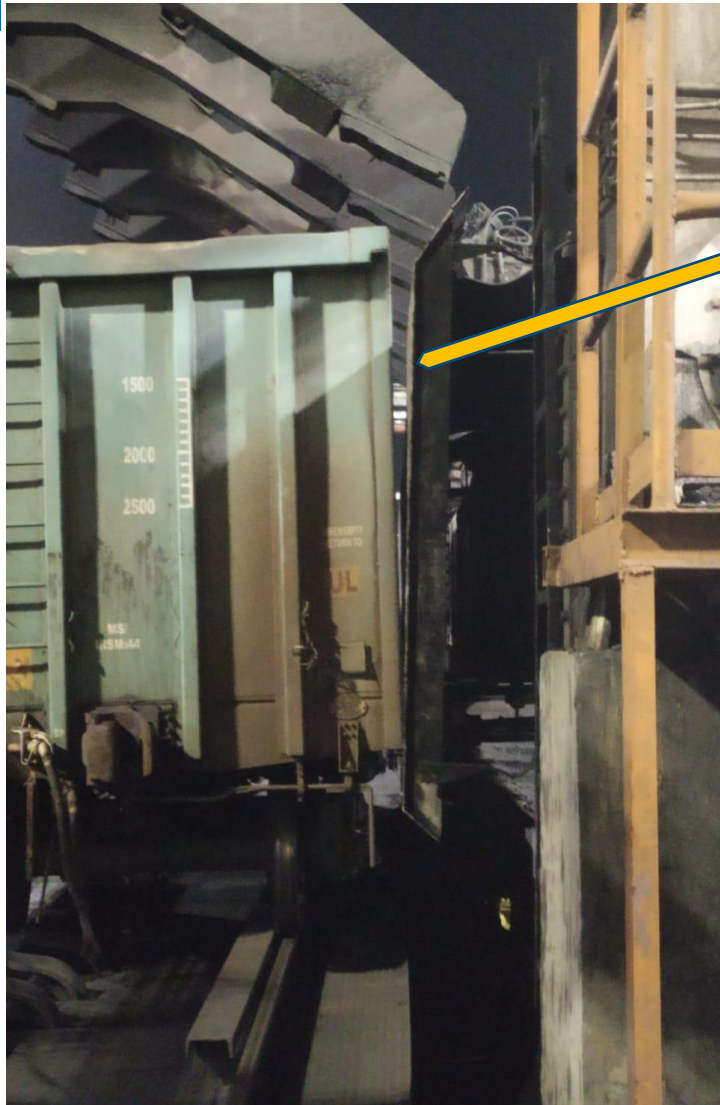
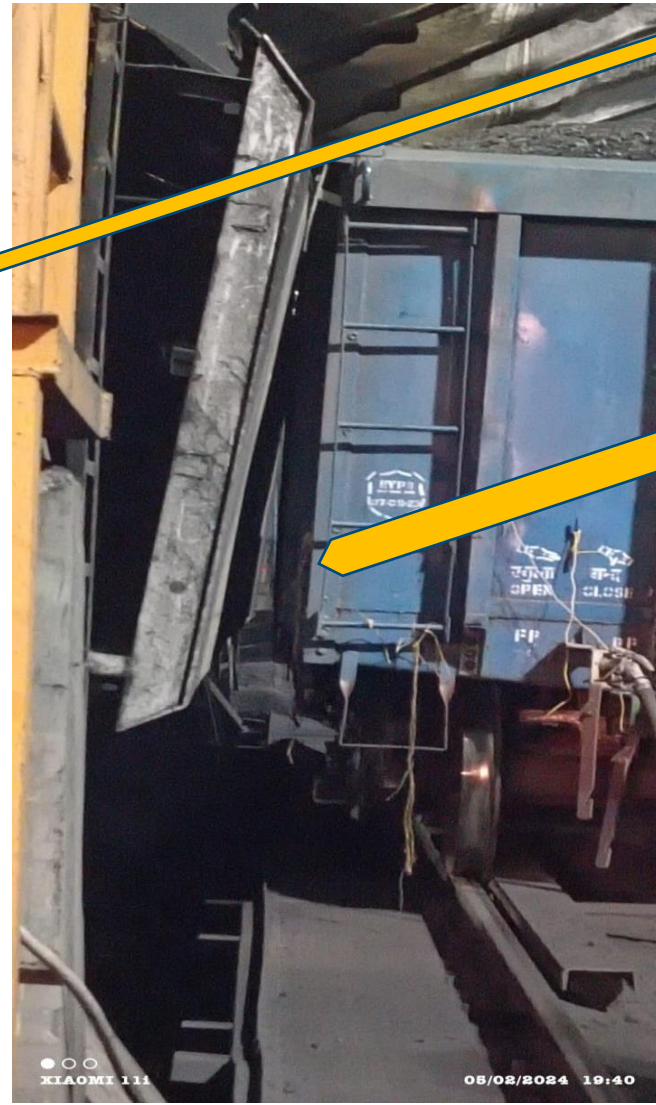
# PROBLEM STATEMENT – SIDE BEAM NOT TOUCHING WAGON PROPERLY

As per RDSO Guidelines  
consult the concerned zonal railway for this confirmation) suitable slots shall be provided in the side support beam, to permit the top clamping of the wagons] **There shall be metal to metal contact between the side support beam and the side stanchions of the wagon i.e. no rubber pad or any other alternative, shall be provided on the contact face of the side support beam**

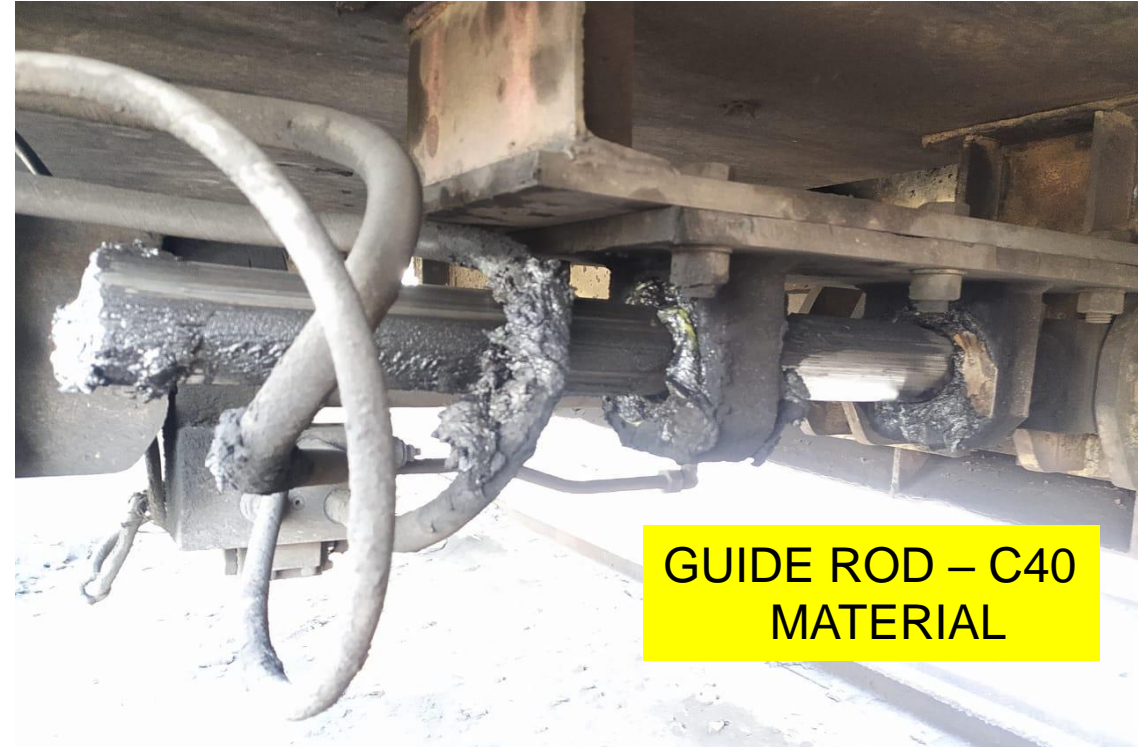
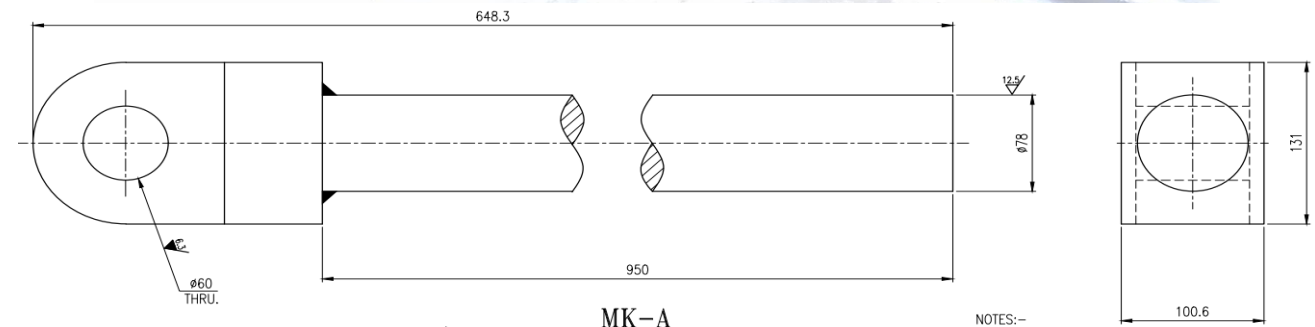
## OEM PG TEST REMARKS

- iv. **Movable side beam** -During PG test we understand from site that due to obstruction of Dust for side movable clamp, it took more time during function of the guide rod of the side movable clamp. After greasing, the guide rod may work properly & the efficiency can be increased. This item is subjected to continuous maintenance supervision for smooth and efficient functioning.

Probable Cause	Action Taken
Flow cum pressure at each cylinder end not same	Pressure Checking done . Flow divider is not at centre. (Inhaul side – 12 mtr / Outhaul side – 2 mtr) Equalisation of all cylinders done if it is required.
Obliquity of Side Beam (Taperness)	Not very significant
Cylinder Forward MOVEMENT not even	Being checked on regular interval but may change
Guide shaft material being soft and high stress stiffening	Material is soft . Future procurement high grade can be used
Cylinders damage like bent piston or internal leakage	Cylinder replacement to be done if found
Pressure Switch healthiness	Regular operational checks
Misalignment of Guide Shaft	Checked and old guide shaft replaced with new one and alignment checked – Aug 2022

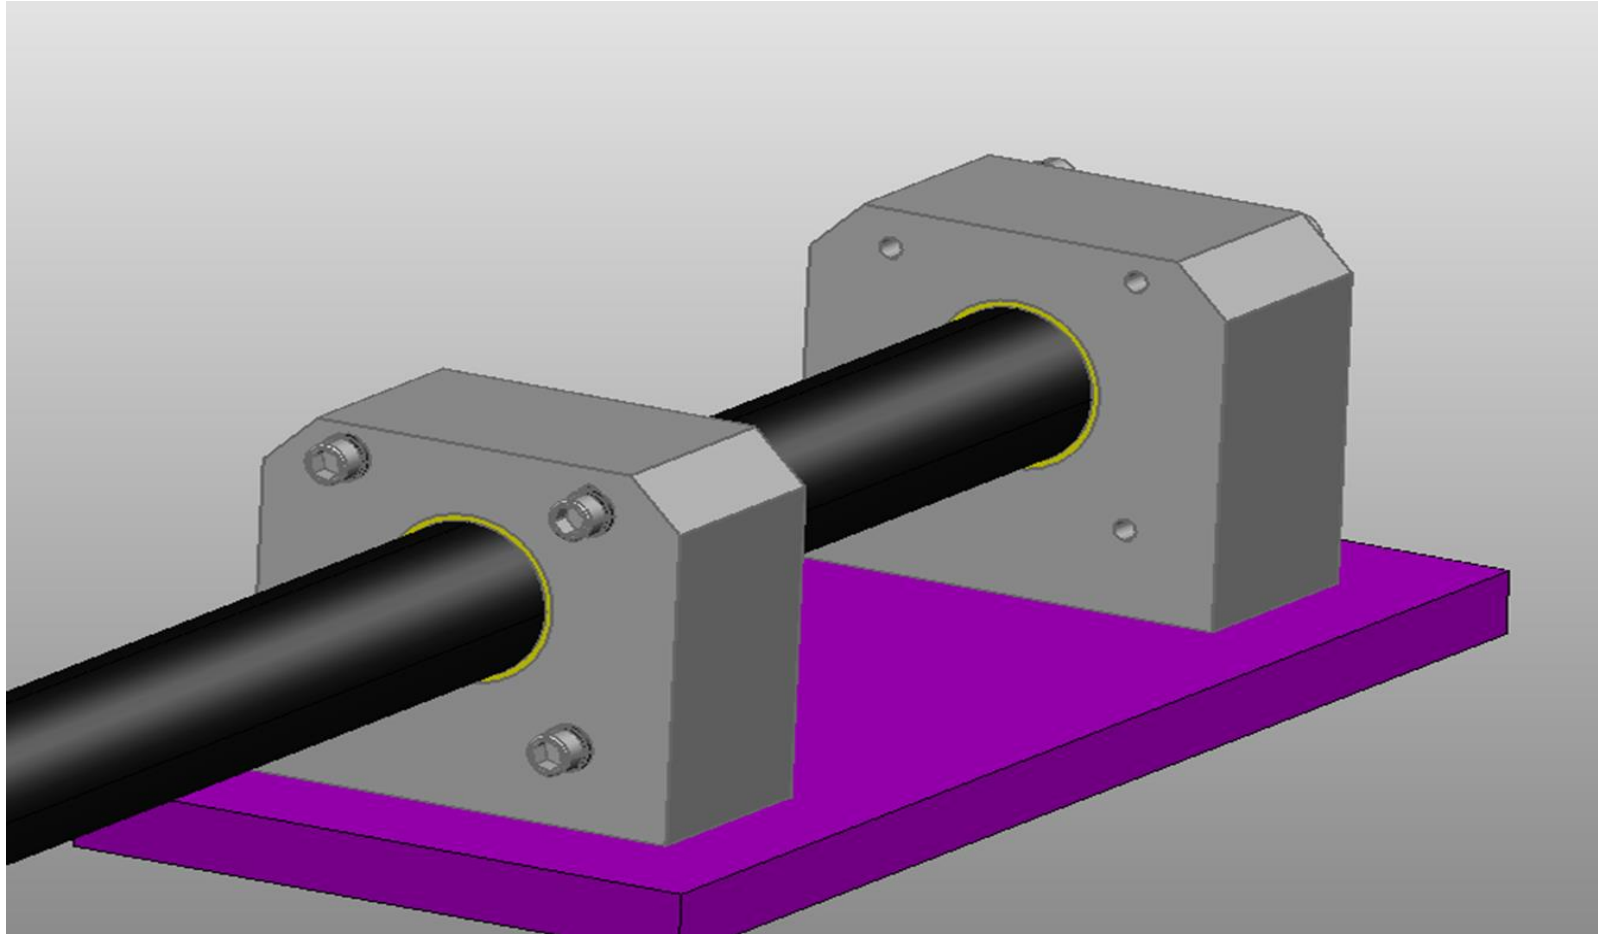
OLD DESIGN

Old Design – Shaft movement with PB2 Bush in open environment exposed to dust

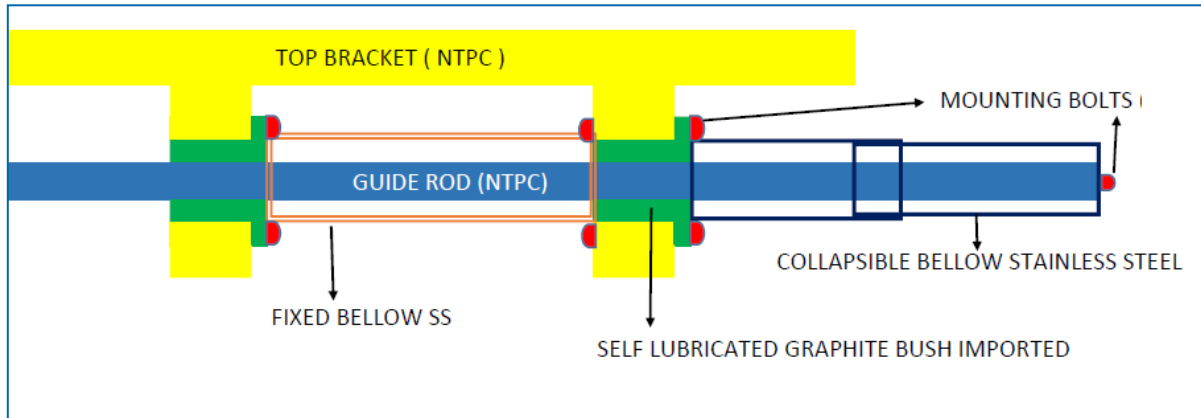
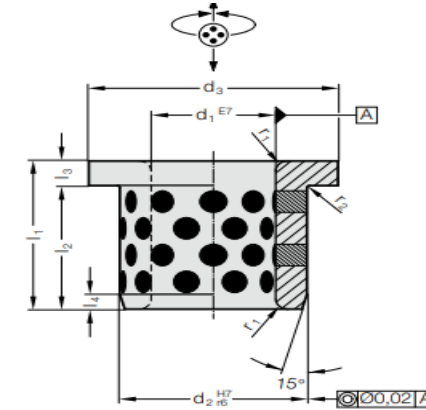
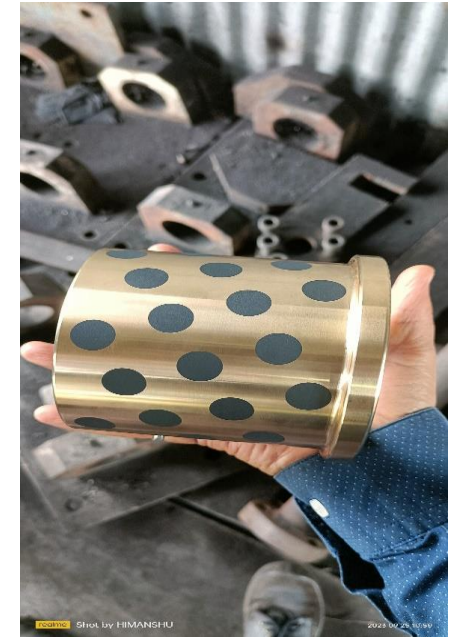
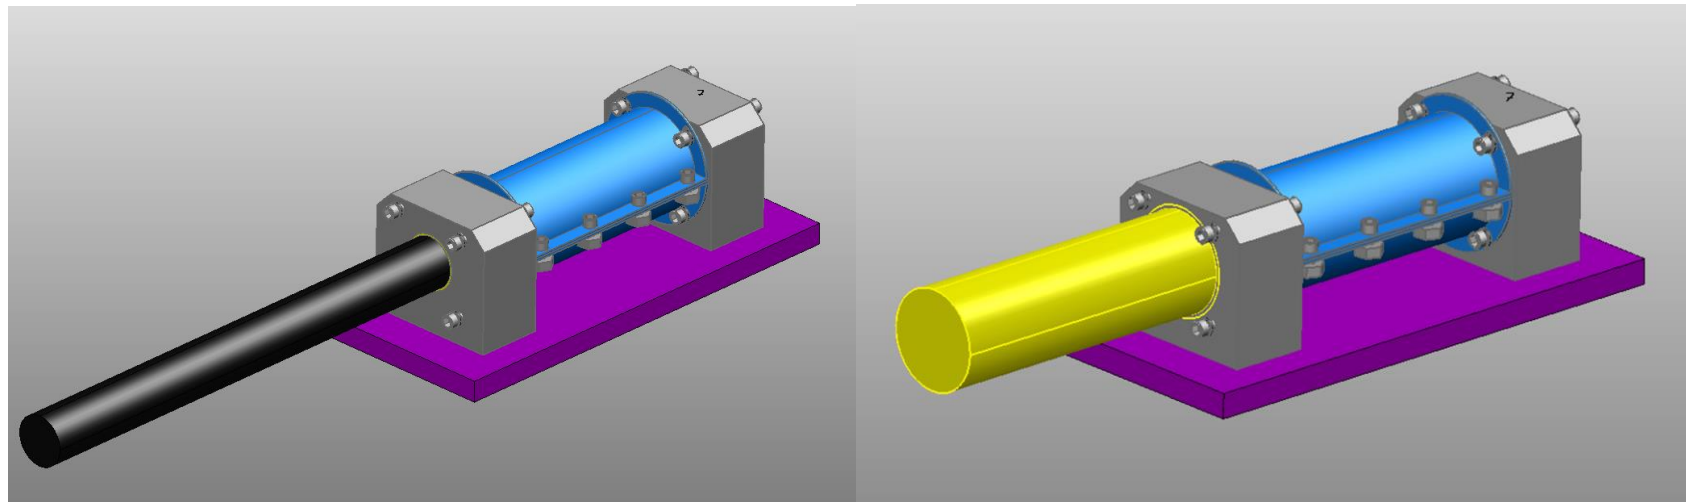
NEW DESIGN

**Material:**  
Bronze with solid lubricant, oilless lubricating

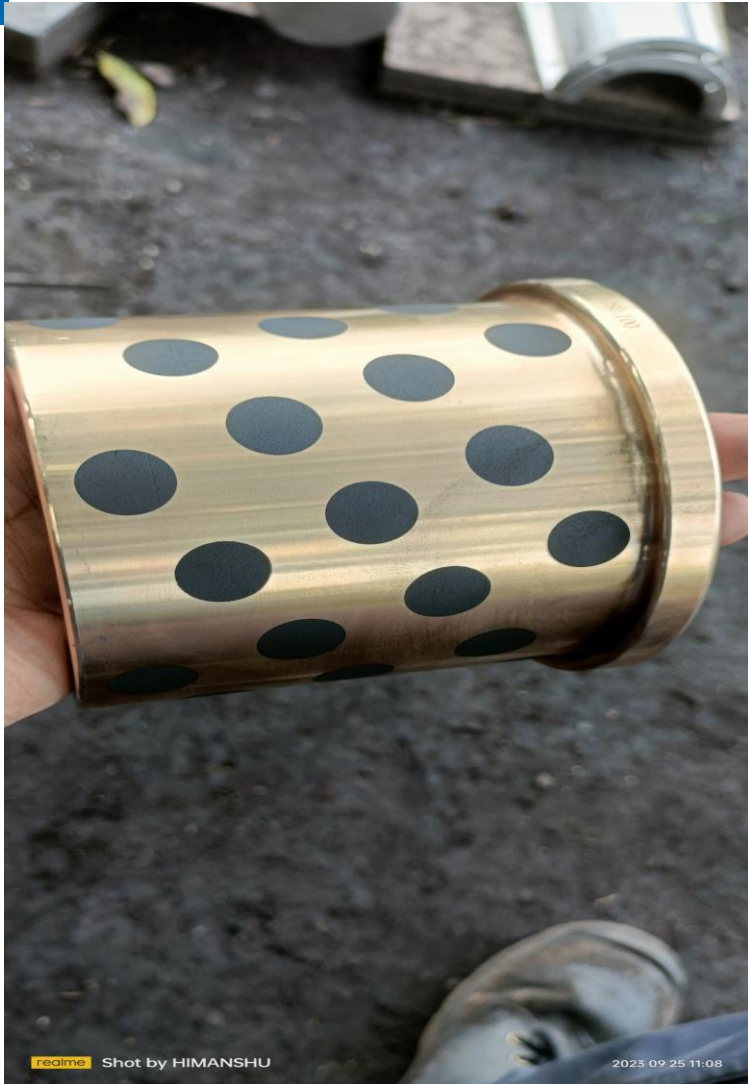
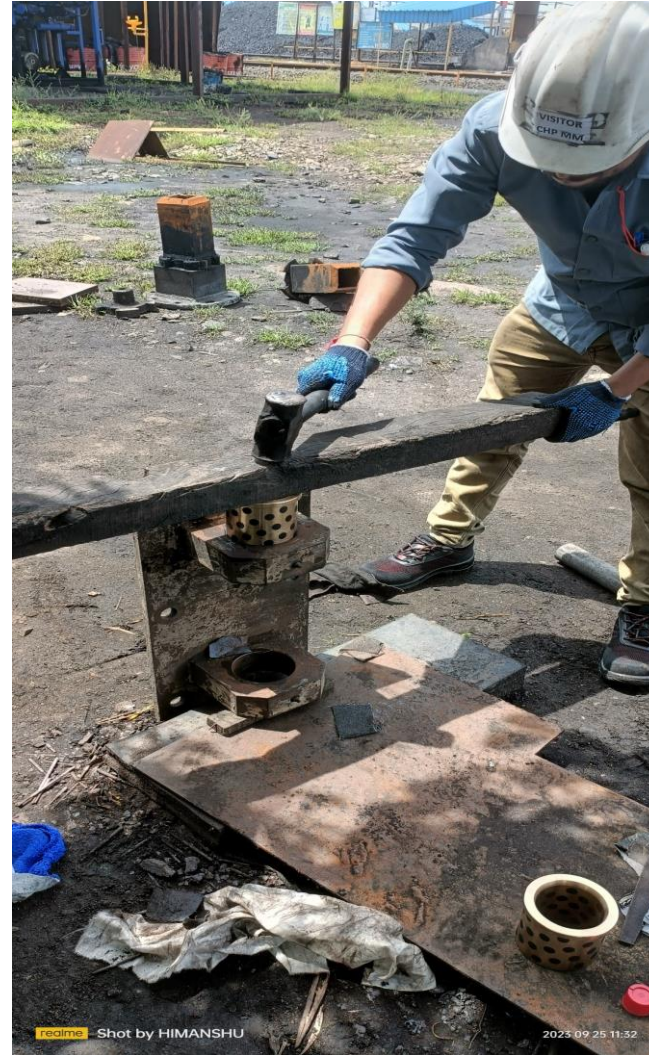
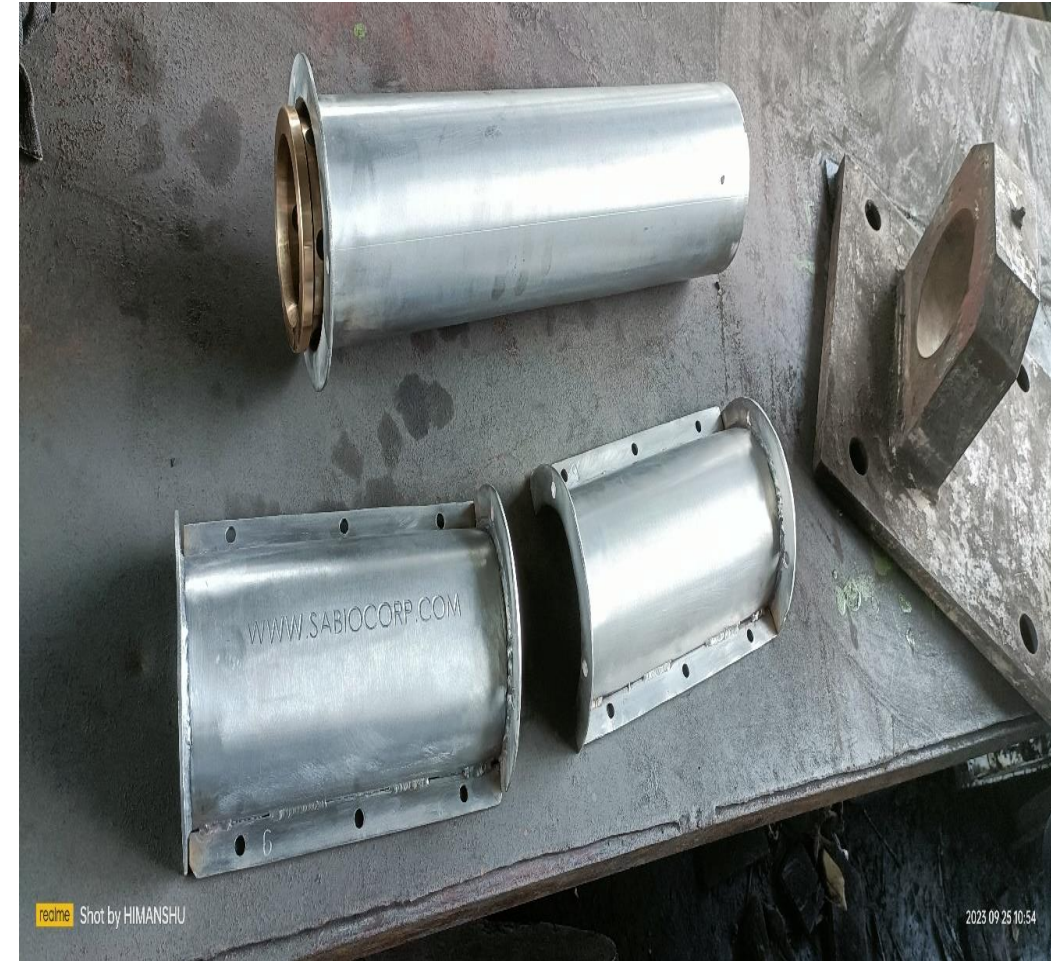
# SEALGUARD ASSEMBLY DEVELOPMENT – FUNCTIONAL TESTING

2. Assembly was done in presence of NTPC CHP Team till 29<sup>th</sup> Sep 2023.
3. Following Assly procedure was followed :-
  - a. 12 Oil less Collar type bushes were press fitted in Base brackets after removal of old bush followed by bore cleaning. ( refer Pic 1)

- b. Bush Face butting with Base bracket was ensured.
  - c. Cup type (SS 304 material )cover assly was fitted with 3 M10 threaded studs which were TIG welded to bracket. ( refer Pic no 2)

- d. 5 mm rubber packing was fitted between Cup type SS cover & bracket face to ensure perfect sealing. ( refer Pic no 3)
  - e. Central split type cover (SS 304 material )was also fitted with 5 mm rubber sheet packing to ensure perfect sealing. ( refer Pic no 3)

- f. Additional greasing nipple arrangement was provided so that regreasing can be done externally without disassembly of the whole system. ( refer Pic no 4)

4. All 6 child part sub assemblies as per BOM of abovesaid PO at Wagon tippler Site between 25 Sep to 29 Sep 2023. ( refer pic 4 & 5 )
5. Dry run / Trial Run after fitment was found satisfactory (smooth , without any noise ) on **30<sup>th</sup> Sep evening.**

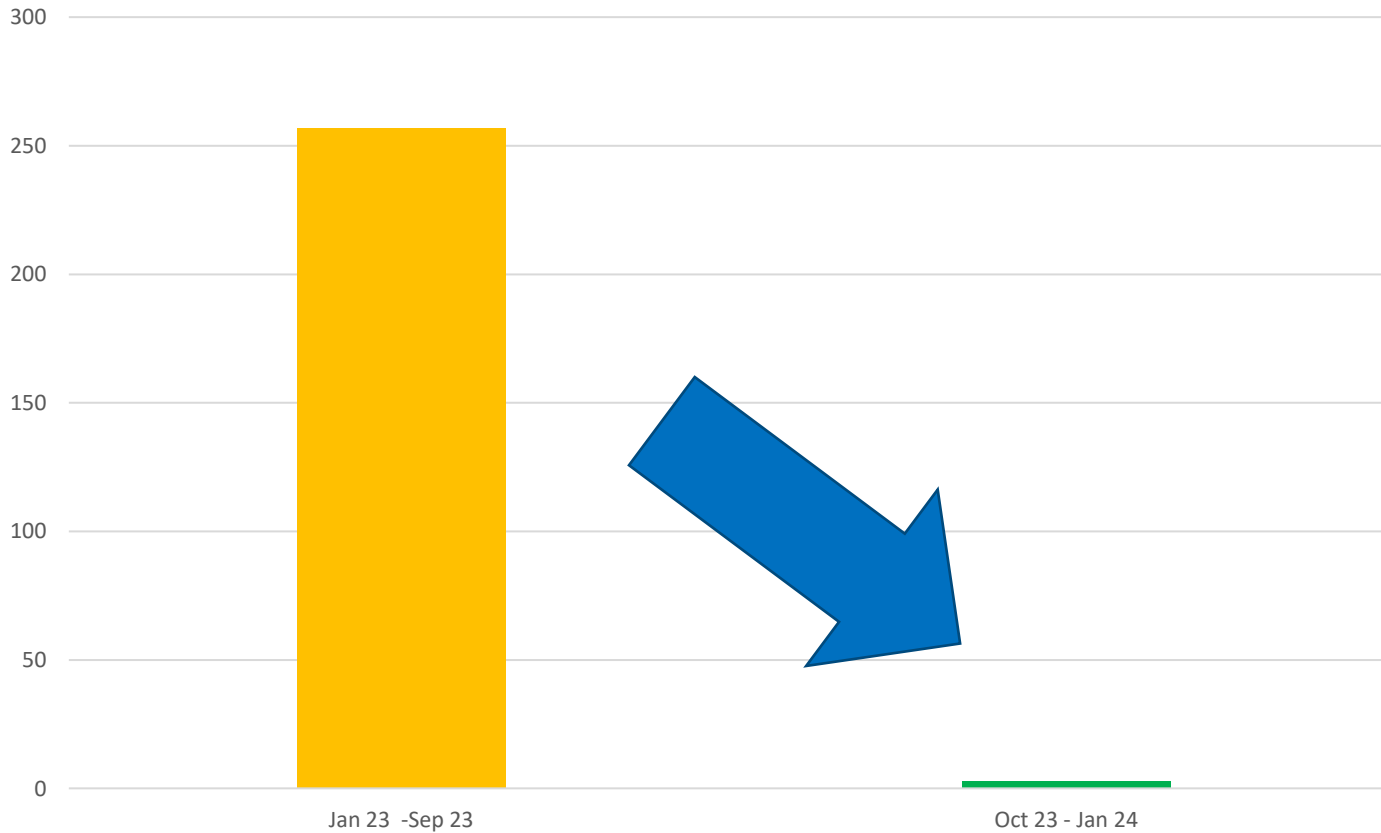
Guide Rod Greasing Requirement

Greasing Frequency decreased 60 times per month to 1 time in 3 months. SAFETY FACTOR increased and maintenance cost reduced exponentially.

Break Even Period of Retrofitment of Sealguard = 5 Months

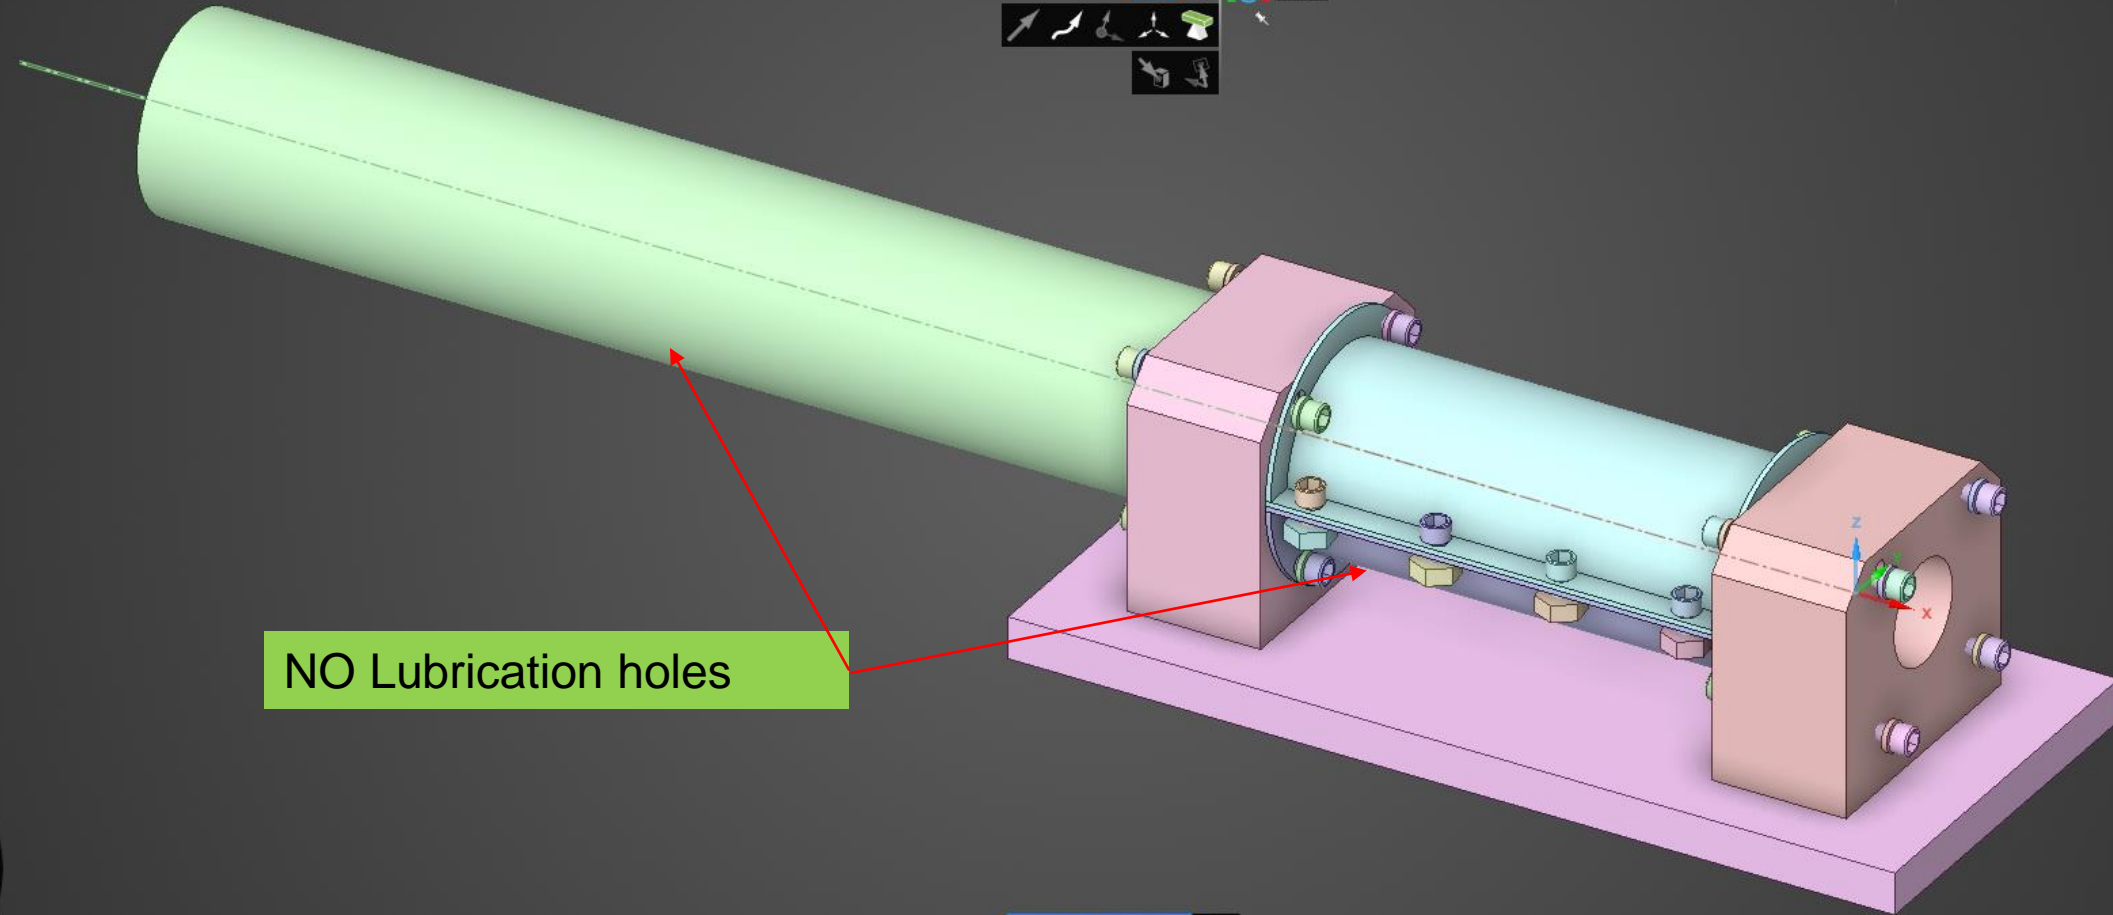
NO Lubrication holes
