ADVANCED ELECTROMAGNETIC TESTING

FOR BOILER TUBE INSPECTION

AET FOR BOILER TUBE INSPECTION

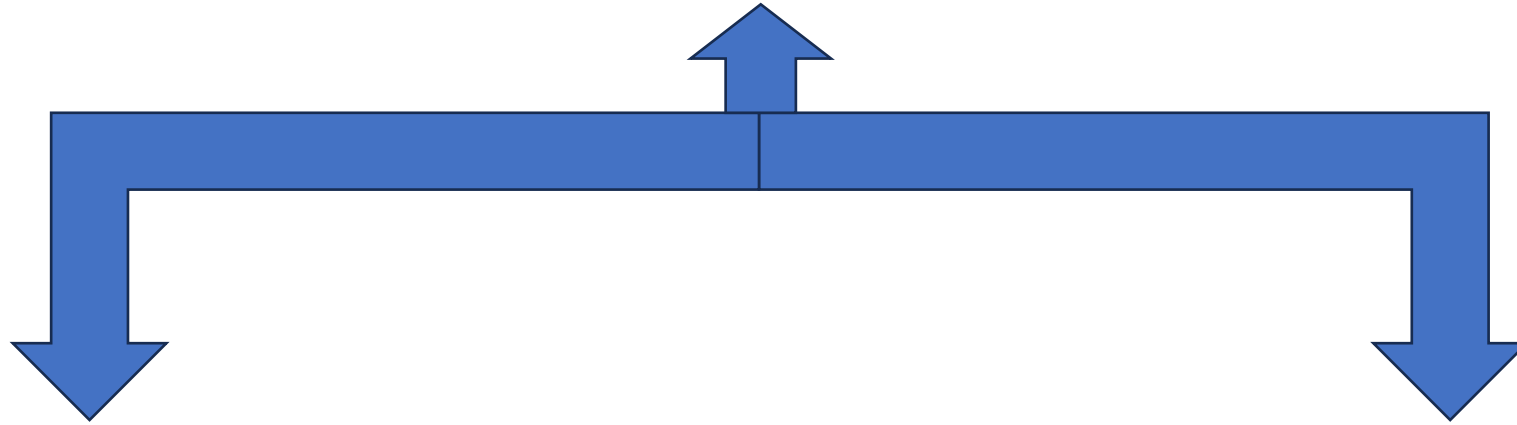
- **Remote field testing (RFT)** is a method of non-destructive testing using low-frequency AC. whose main application is **finding defects in ferrous tubes.**

- An RFT probe employs an exciter coil to emit an AC current-induced magnetic field through the pipe wall. This magnetic field travels outward along the pipe's interior and also penetrates through the pipe wall. Positioned at a distance of two to three pipe diameters away from the exciter, the receiver coil detects any leakage of the magnetic field caused by defects or metal loss in the pipe's structure.

- **AET** share the same basic principle. Alternating current injected into a coil creates a magnetic field. When the coil is placed over a conductive part, opposed alternating currents (eddy currents, in red) are generated. Defects in the part disturb the path of the eddy currents. This disturbance can be measured by the coil.

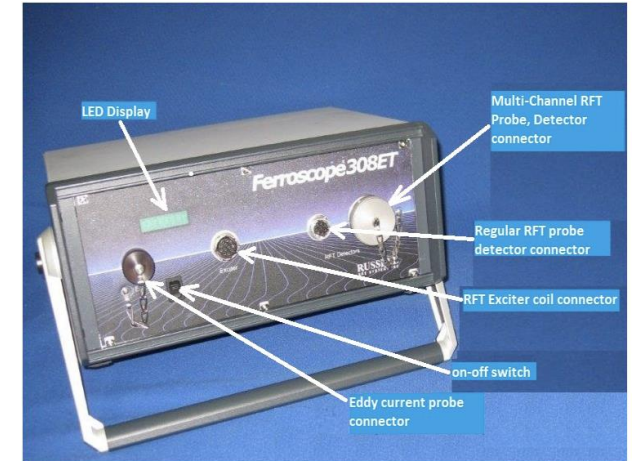
(FERROSCOPE-308ET)

- RFT (E-Pit tool) is primarily used to inspect ferromagnetic tubing since conventional eddy current techniques have difficulty inspecting the full thickness of the tube wall due to the strong skin effect in ferromagnetic materials.
- E-pit tool has two receiver coils: one is absolute for detecting general wall loss in the near field zone, and another is differential for identifying localized defects like pits, cracks & material degradation in the remote field zone.
- E-Pit Tools are designed to inspect tubes & pipes from the outside surface to detect internal (ID) & external (OD) defects. This is useful for situations where a pipe must be inspected before it is taken out of service. E-Pit can inspect upto 12mm thickness through coatings.
- Scanning speed ranges from approximately 0.3 to 8.6 meters per minute, depending on the thickness of the material being inspected.

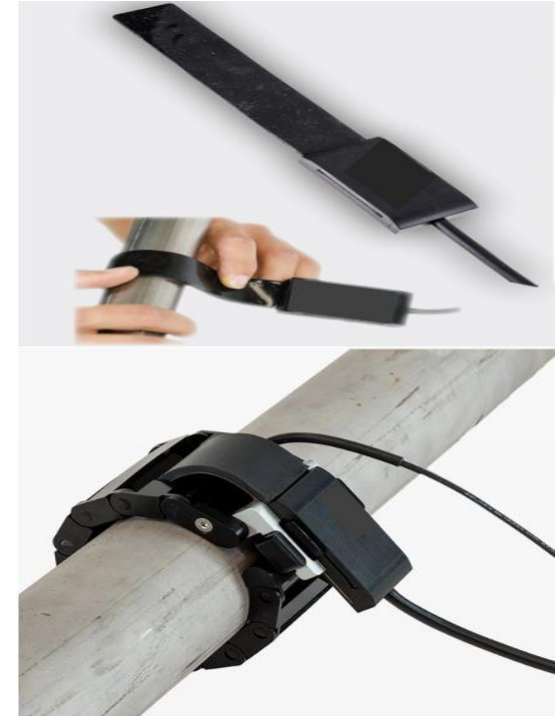
- The Flex probes seem to be highly regarded in the non-destructive testing (NDT) industry. They are described as flexible and plug-and-play AET probes, which means they are easy to use and can adapt well to various inspection scenarios.

1. The probes are highly flexible, conforming to complex geometries and surfaces.
2. The Flex probes maintain excellent performance without compromising accuracy.
3. They allow for efficient one-pass examinations, reducing inspection time and increasing productivity.
4. The probes are equipped with real pancake coils, enhancing their ability to detect surface and subsurface flaws with excellent signal quality.
5. Detection like pitting, crack and mostly metalogical degradation.

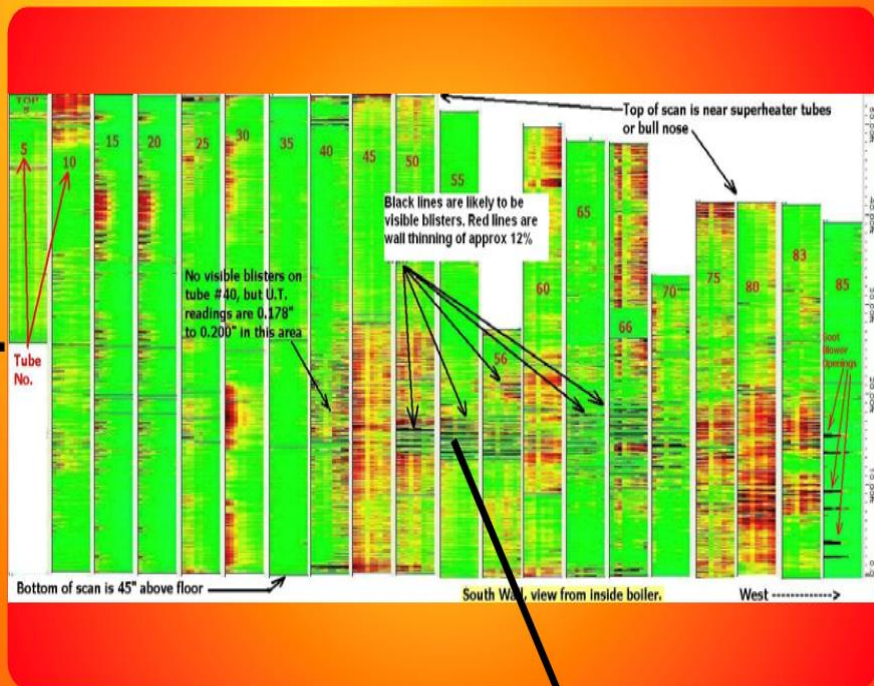
The results are displayed as color maps, strip charts and voltage planes.

In the image at right an entire water wall is mapped (every 5th tube)

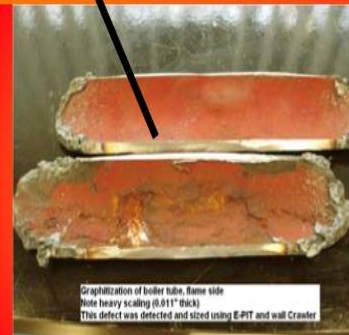
In the sample at right, the internal defect detected was graphitization. Also detectable are: internal pitting; thermal fatigue; soot blower erosion; blisters; flame erosion; hydrogen attack and chelant corrosion.
