Interconnection of New Cold water channel with Existing Channel of Rihand Stage III

cold water from Helper cell through new channel to be done in the existing channel.

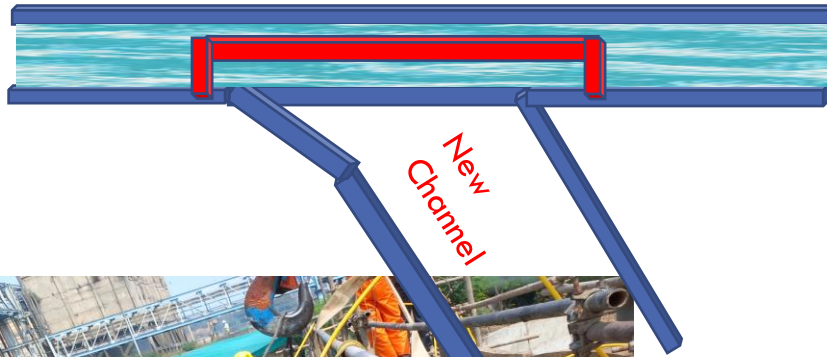
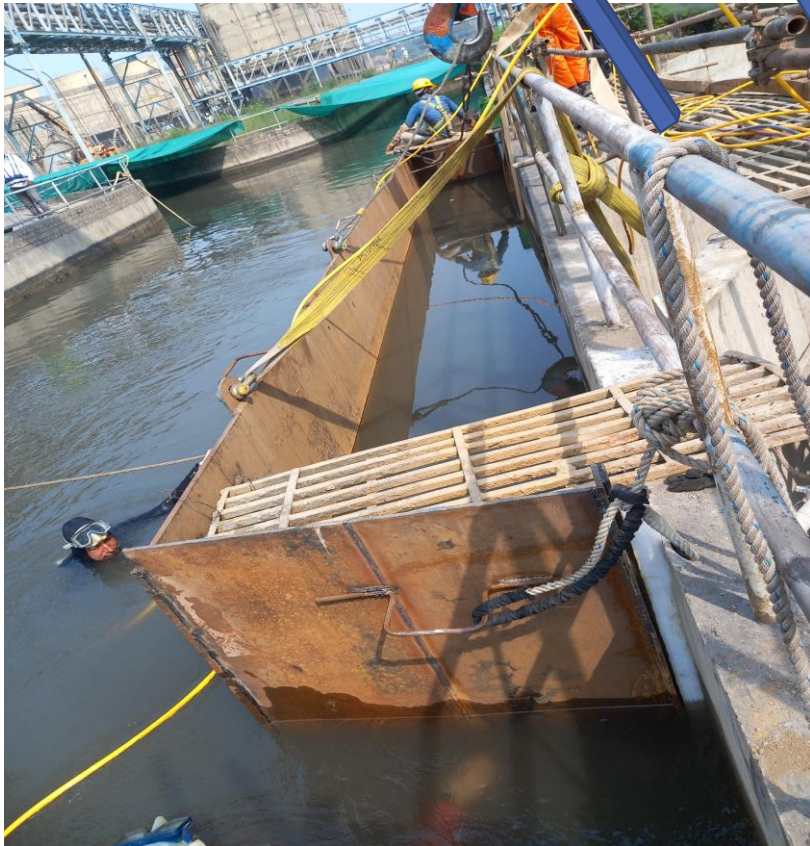
Methodology	Challenges faced
<ul style="list-style-type: none"> ➤ Approved by Engineering. ➤ 20 mm MS plate 9 mts length to be placed. ➤ Sealing of the plate with wall surface by rubber gasket material to avoid any water leakages ➤ Fixing prop supported from opposite wall of the existing channel to keep the 200 mm plate in position. ➤ Drilling of holes at the base of wall (at 2 corners) from new channel side. ➤ Drilling of holes at the top of wall (for lifting of the wall section). ➤ RCC wall cutting by diamond rope. ➤ Water filling in the new channel. ➤ Lifting of the wall. ➤ Lifting of the plate.. 	<ul style="list-style-type: none"> ➤ Plate could not be packed with existing vertical wall due to water flow. ➤ Sealing with wall couldn't be possible. ➤ Diamond cutting wire was frequently broke down due to high water pressure and 20 mm MS plate plate with existing wall. ➤ Plate was close to wall, hence there was no way to loosen the rope from the water side. ➤ Resulted in no work progress on Day -1 – 15.02.23.

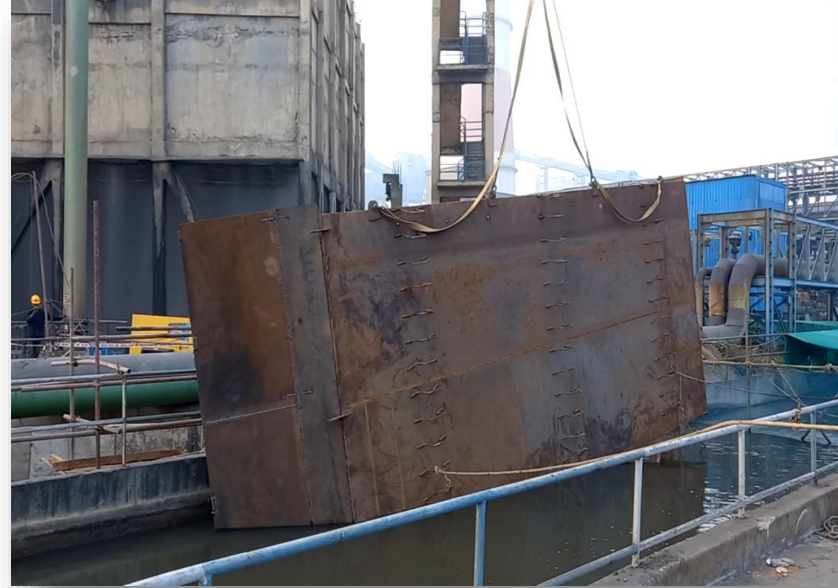
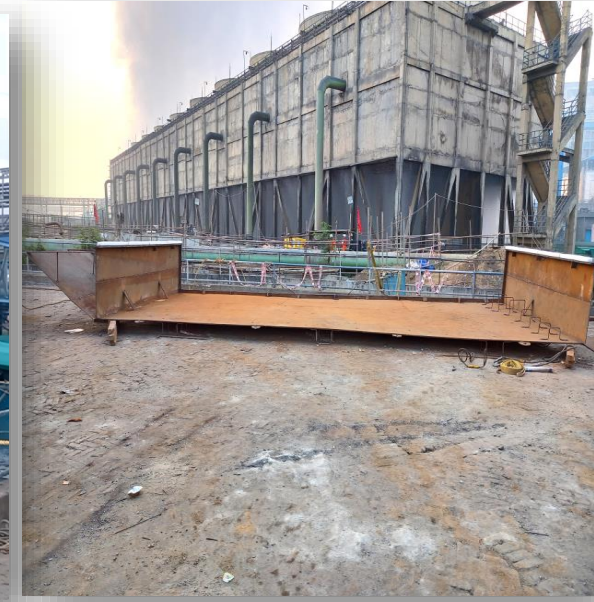
Setting up C Section

Methodology	Challenges faced
<ul style="list-style-type: none"> ➤ Mythology was modified at Site which mainly consist of C section of 20 mm MS plate instead of plate. ➤ Sealing of c section edges by rubber gasket and foam. ➤ Core cutting for lifting to facilitate sling operation. ➤ Dewatering of enclosed area by pump. ➤ Net barricading in D/S for safety. ➤ Dewatering between c section and existing wall 	<ul style="list-style-type: none"> ➤ Availability of glue for pasting rubber gasket on edges of C-section. (conveyer pasting glue was used for fixing rubber gasket) ➤ Availability of foam that could withstand in water pressure. (high density foam used)

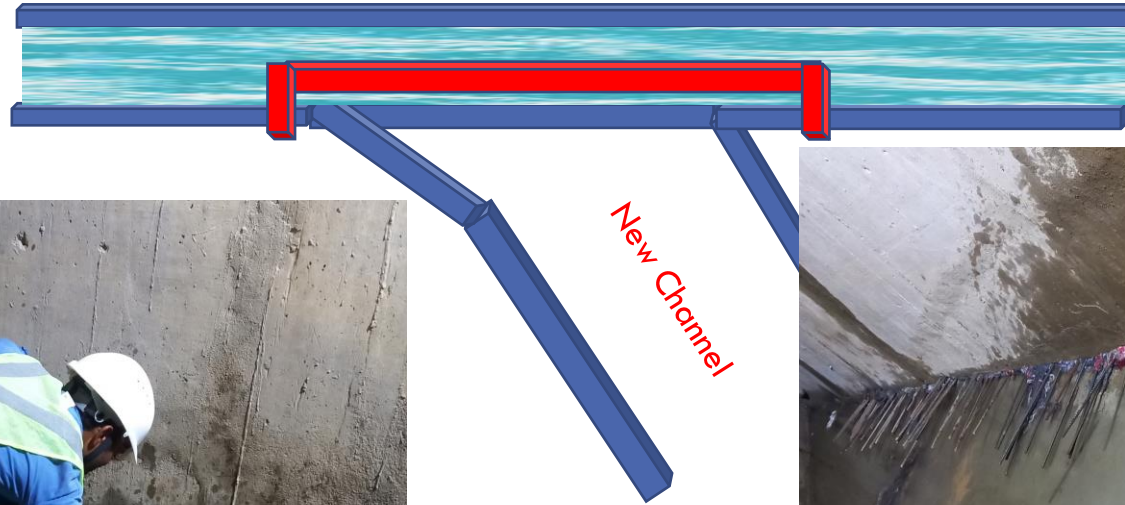
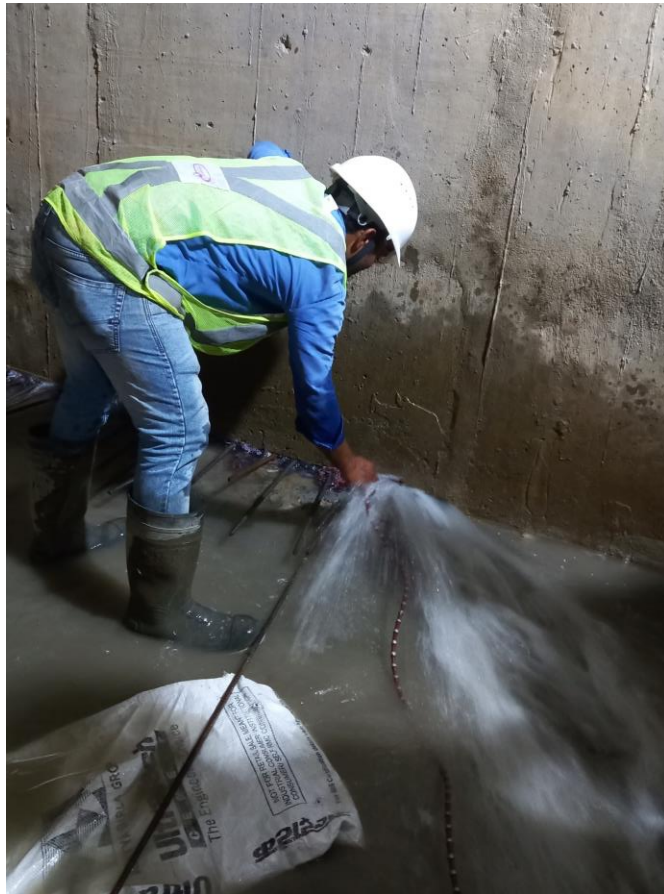
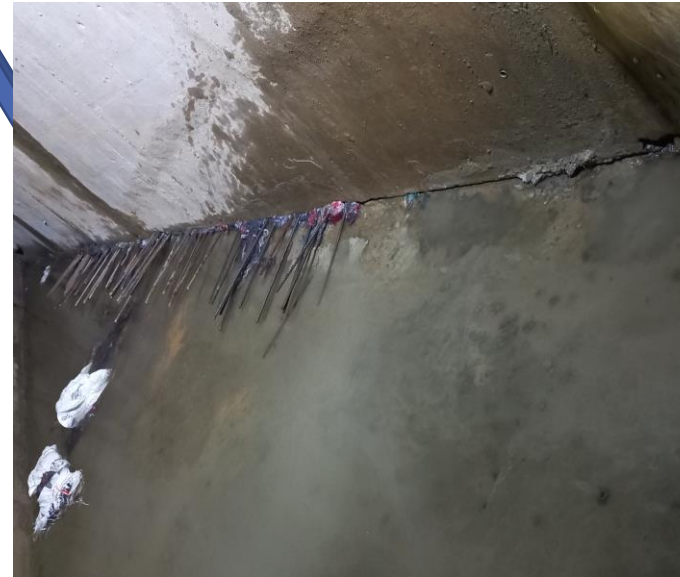
Methodology	Challenges faced
	<ul style="list-style-type: none"> ➤ During the dewatering operation plate started bending due to high water pressure. ➤ Dewatering stopped

Sealing by foam inside and rugs by outside

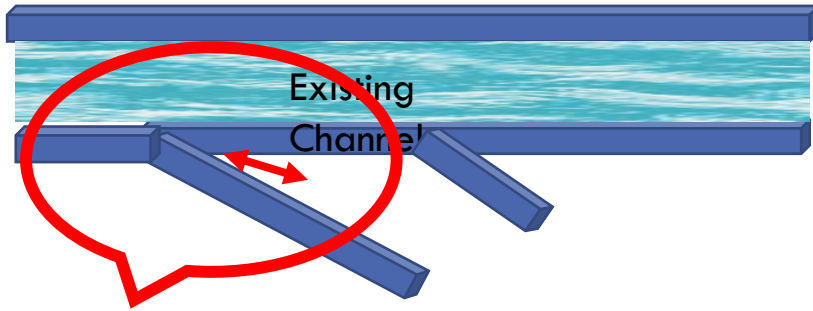
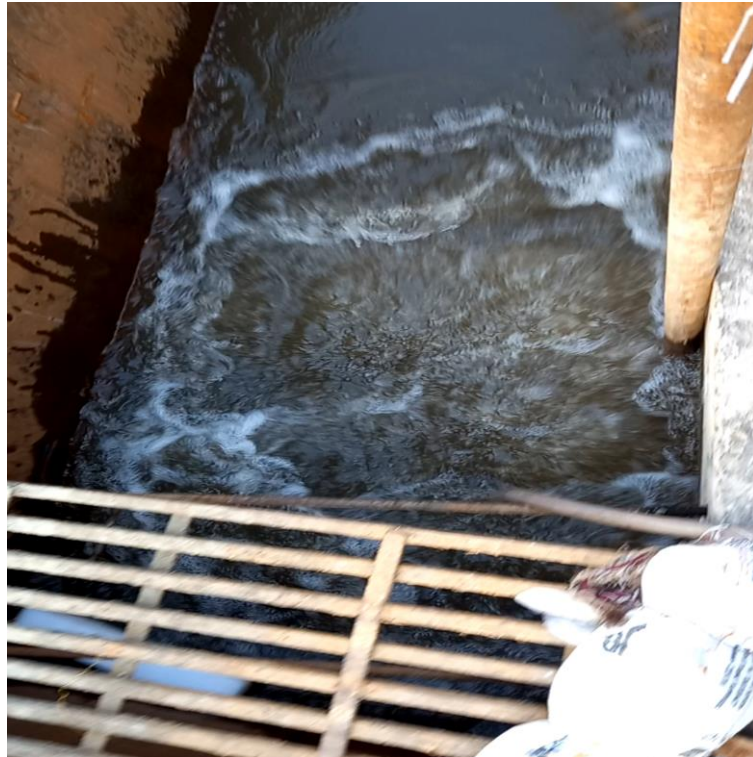
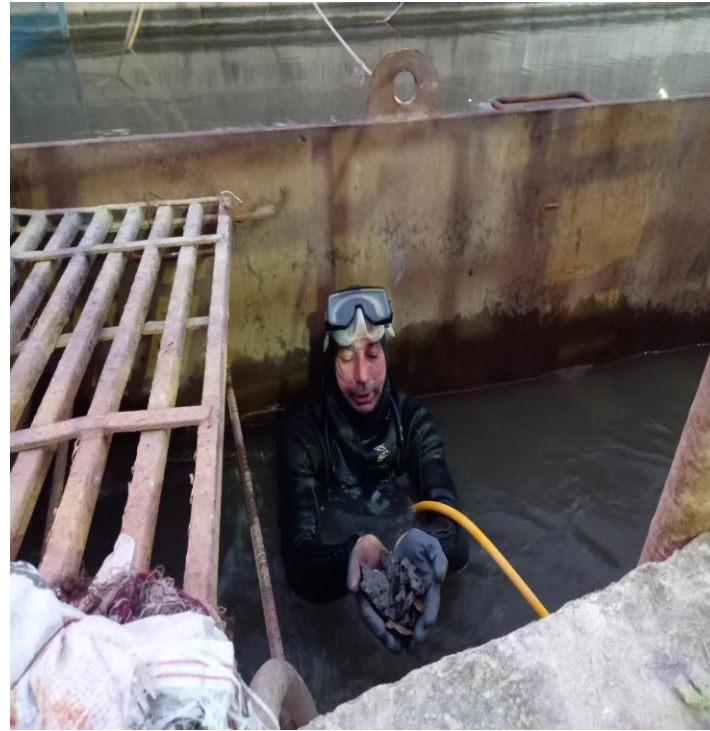
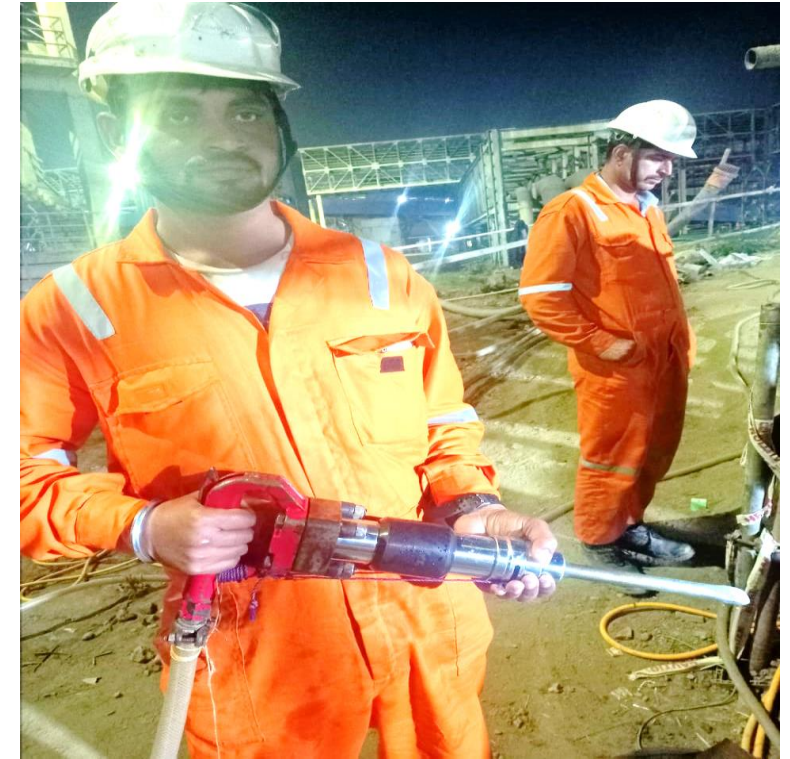
Methodology	Challenges faced
<p>Metholgy was revised & decided to work with water in c section C section benefit was that water inside was still easing the diving operation by divers.</p> <p>Diamond rope cutting machine set-up from new channel. Drilling additional holes at bottom 1.5 mts interval to cult wall in 3 sections</p>	<p>Diamond rope frequently getting stuck to due to longer cutting span of 4.5 mts Due to lower capacity machine, wall thick ness & water pressure cutting rope was breaking – resulting approx. 1-1.5 hrs delay in resuming cutting work (due to underwater wrapping) Resulted in work progress on Day -4 – 18.02.23 Bottom horizontal of the RCC wall was cut.</p>

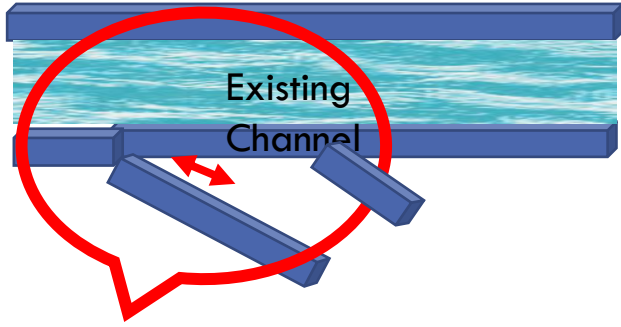
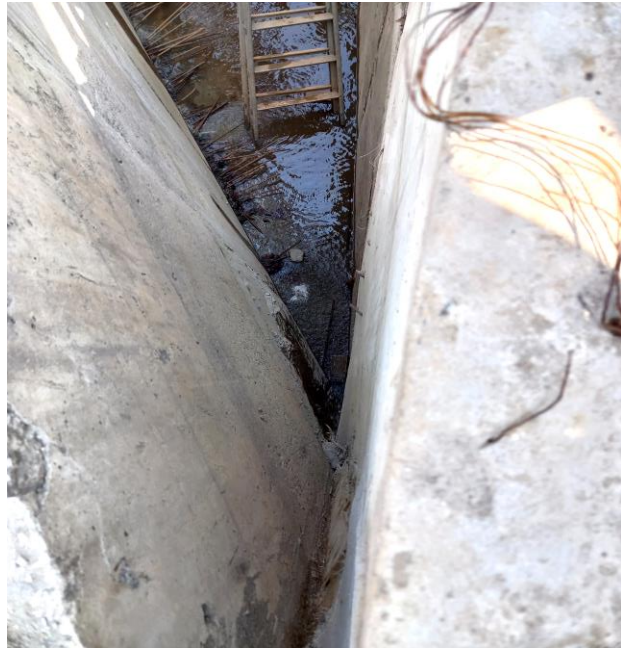
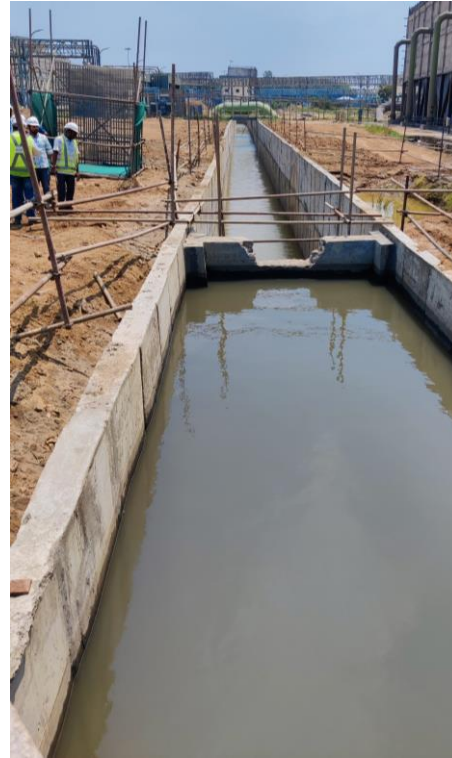
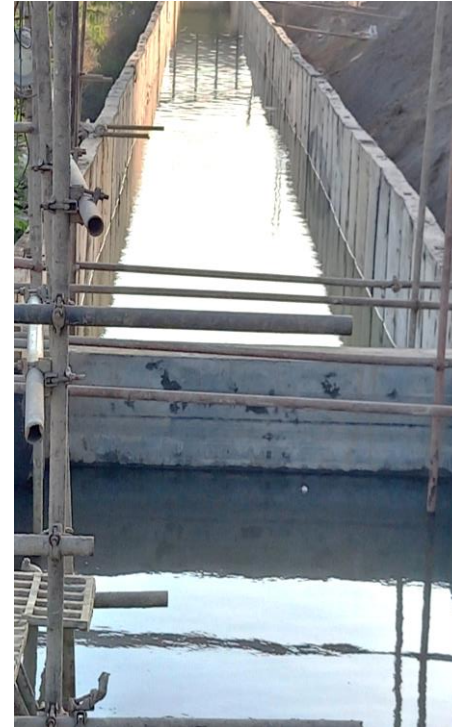
Methodology	Challenges faced
<ul style="list-style-type: none"> Under water jack hammer used for ease drilling operation . 	<ul style="list-style-type: none"> ➤ Space constraint in the kink portion ➤ No space for a perpendicular drilling from new channel side ➤ Inclined drilling tried but the base of wall exceeded the drawing data. ➤ Result of the day – 5 – no progress.

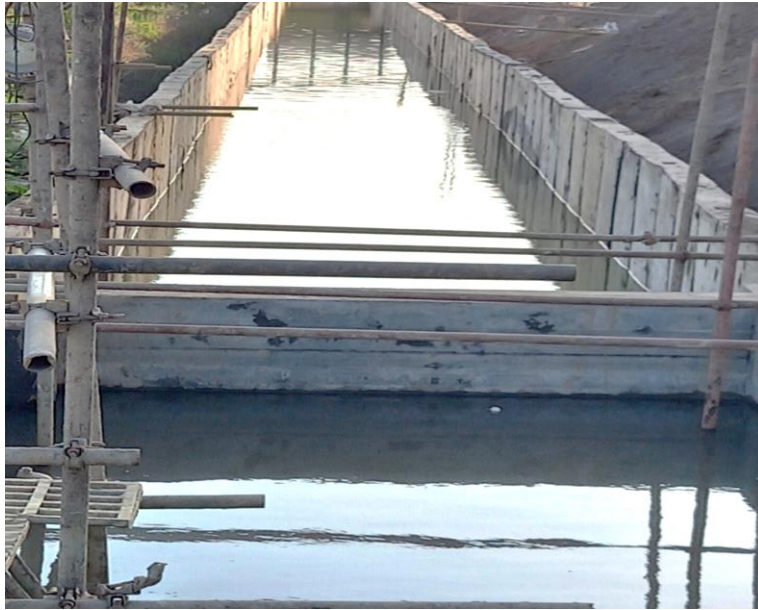
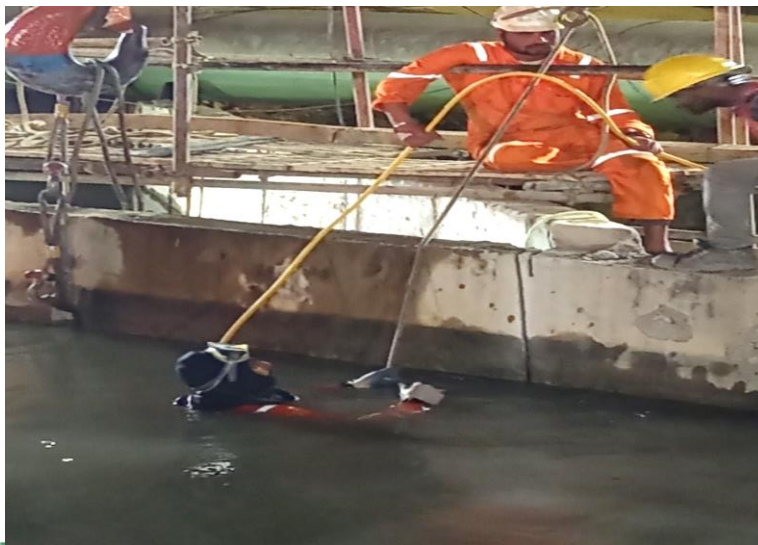
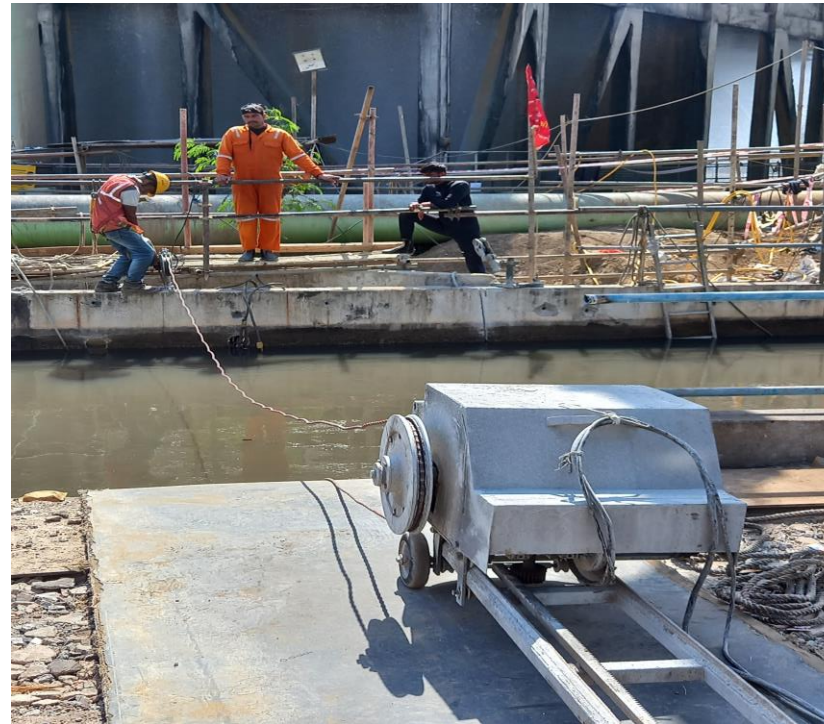
Eliminating the kink

Water filled in adjacent segment of channel to avoid risk of brick wall failure.

Methodology	Challenges faced
<ul style="list-style-type: none"> ➤ Water to be filled before cutting of wall vertically ➤ Set up of cutting machine above wall for vertical cut. 	<ul style="list-style-type: none"> ➤ No challenges. ➤ Progress : drilling at kink portion successfully done, and water filling in new channel done & holes for lifting RCC Panel done.

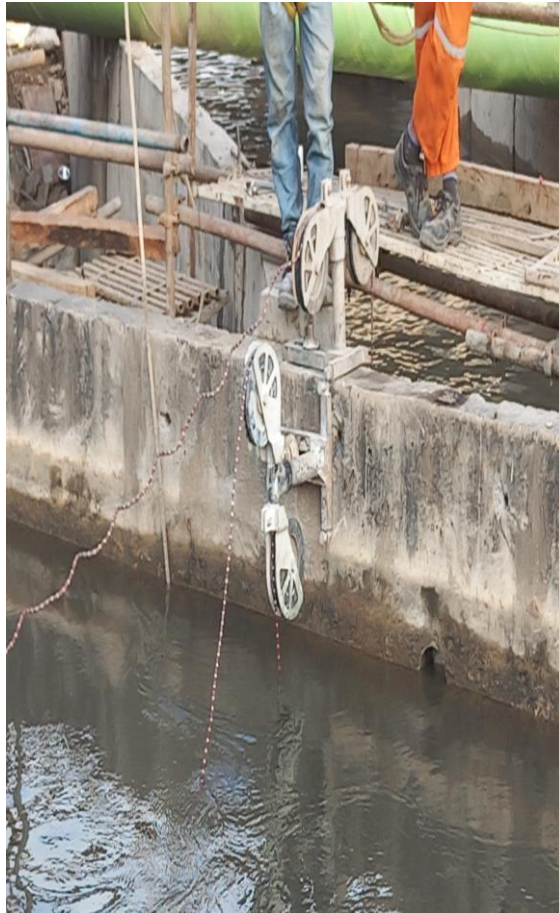
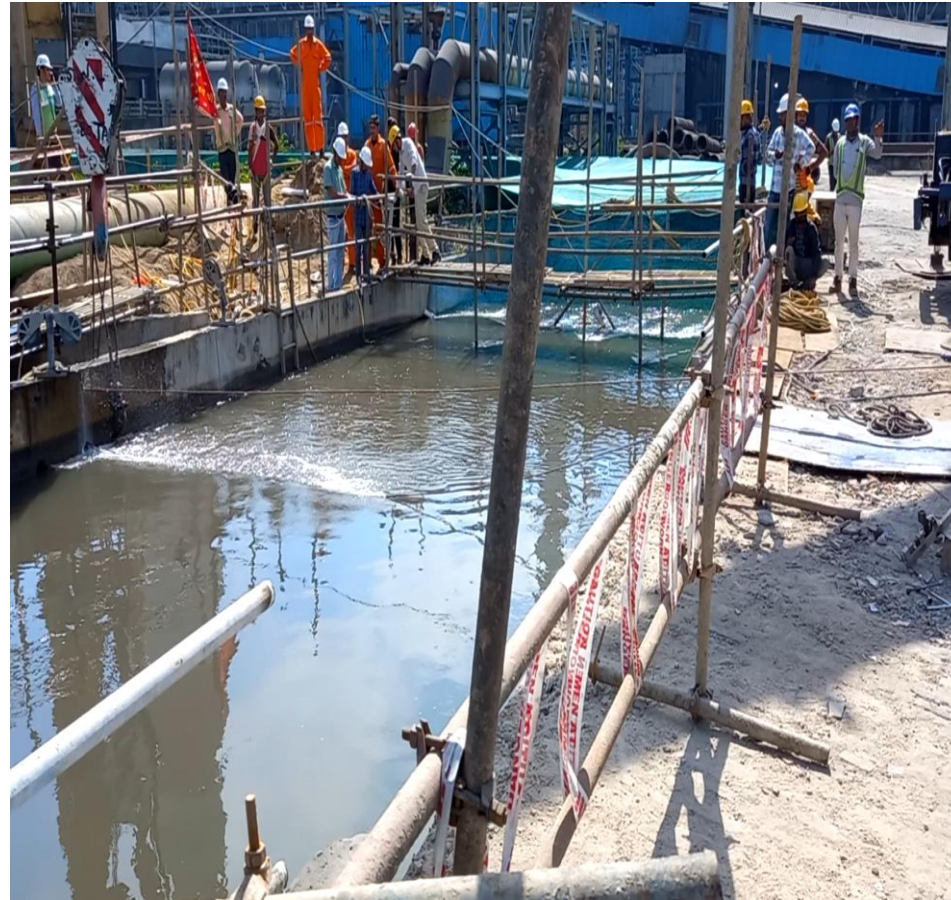
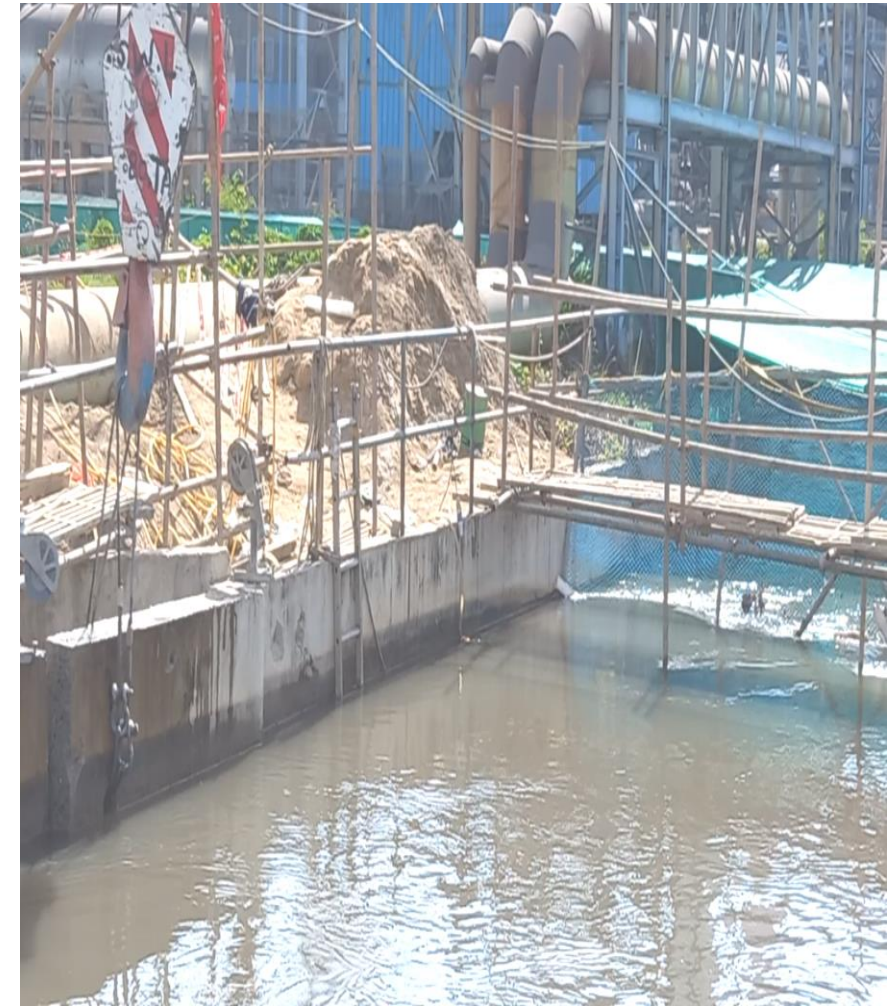
Pulley used to avoid rope wall contact – major reason of rope breakage.

- due to space constraint machine could not be placed above wall.
- Progress : vertical cutting of wall started.

- Set up of cutting machine above wall for vertical cut.
- methodology revised : set up of machine on the other side of channel
- Removal of c section & hand rail was removed

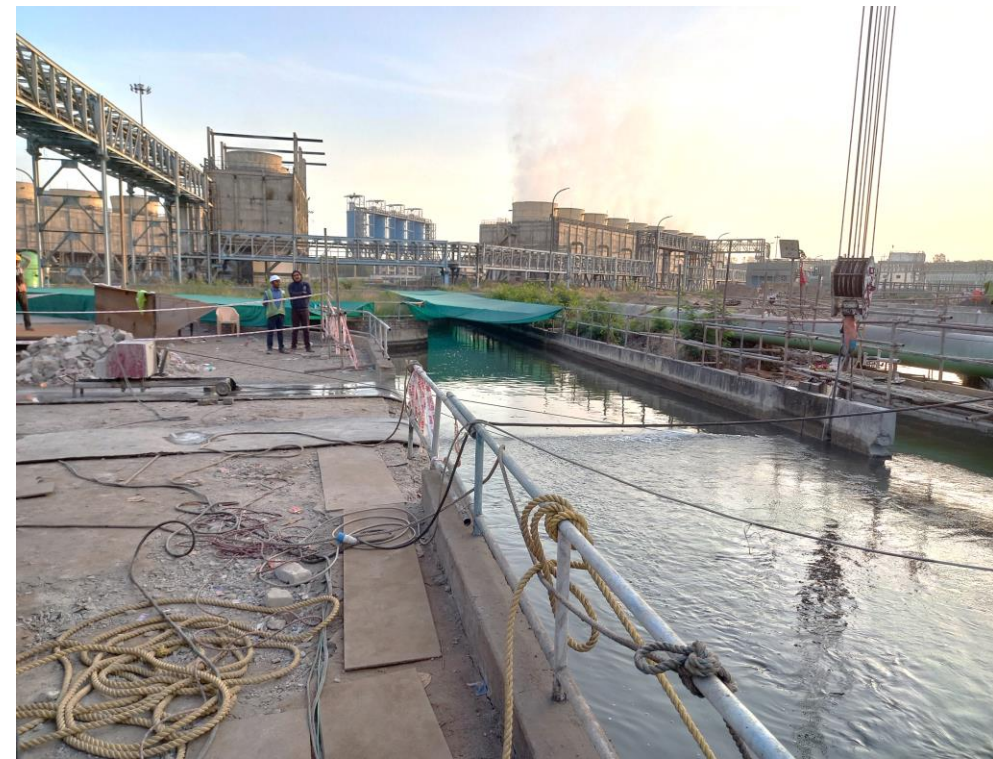
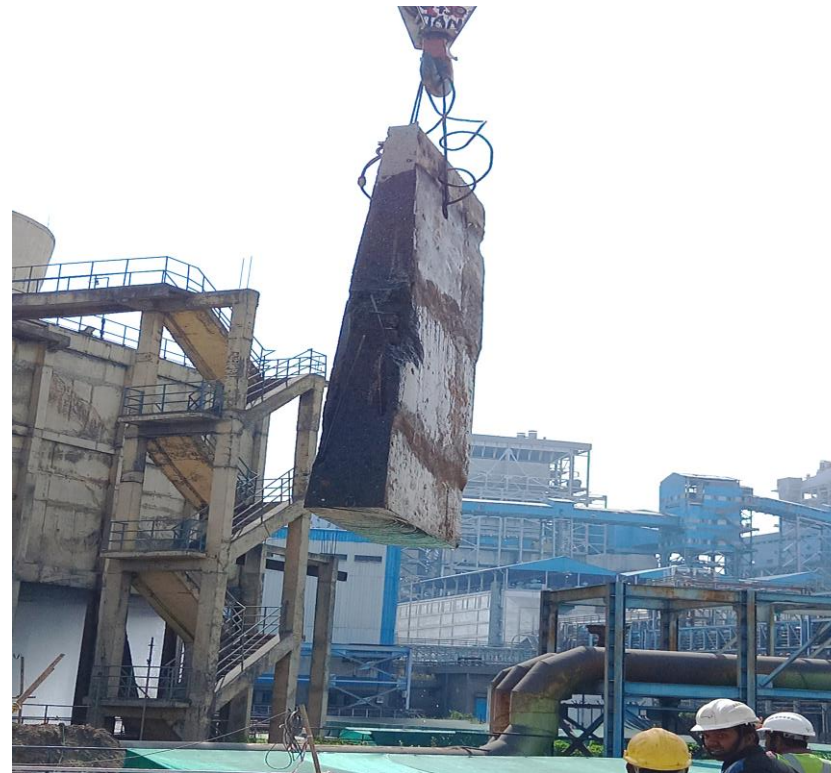
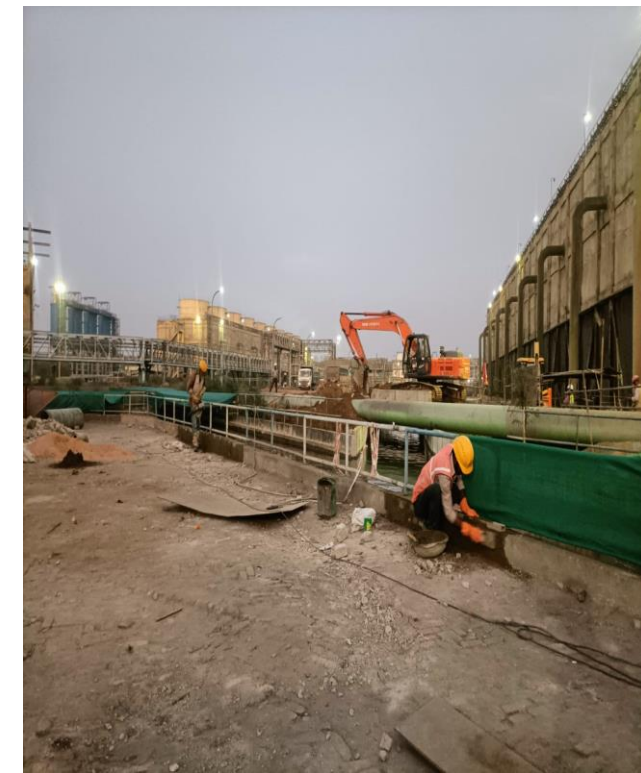
1st panel cut and lifted

3rd wall panel cut and lifted

railing repairing works

Methodology/ working steps	Challenges faced
<ul style="list-style-type: none"> Removal of debris (if any) Restoring of hand rail at existing duct 	<ul style="list-style-type: none"> ➤ Progress : <ul style="list-style-type: none"> 2nd panel & 3rd panel cuted & removed Hand rail repairing work done. Interconnection work completed.
