**A CASE STUDY ON SHIP
UNLOADER
AT
MSTPP/BIFPCL
(Bangladesh)**

Project Name: Maitree Super Thermal Power Project (2 X 660 MW)

FAILURE ANALYSIS

HOLD DRUM

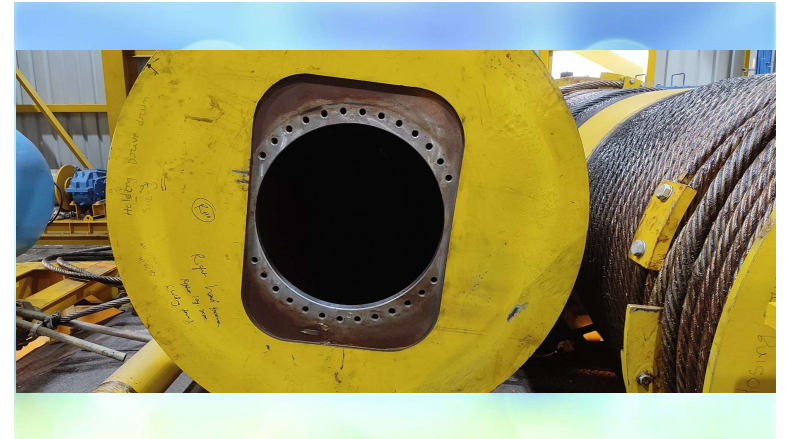
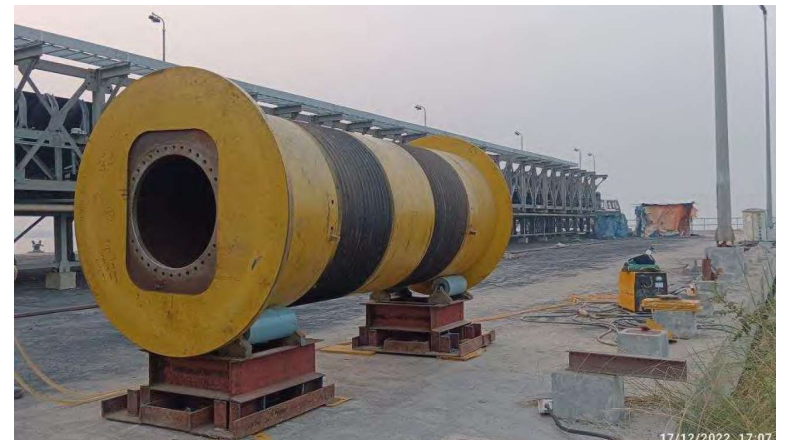
CATEGORY:1: Failed SUL 3 hold drum.

Sending the drum to India & get it repaired will lead to a huge delay, so necessary repair work was done at the BIFPCL site.

SUL-3 -Grab Hoist drum had removed from the machine for the welding rectification & after resting it on rollers necessary rectification work done at site.
