A Comprehensive Analysis by PAUT of Stress Corrosion Cracking (SCC) in Austenitic Stainless Steel Super 304H & 347H Grade Tubes in Super critical thermal power plant

B C Roy , R K Jain , U. Srinivasa Rao , Aditya Kumar Gupta

IPS 2024, RAIPUR
Date : 13-15 Feb

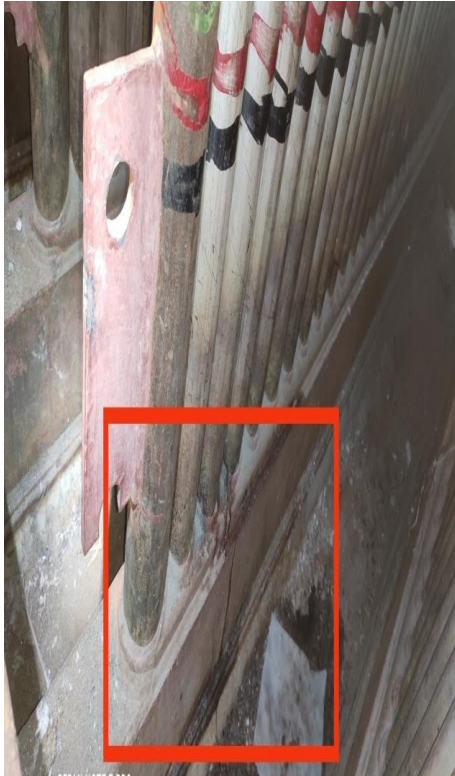
FINISH RE-HEATER (FRH)- TYPICAL ARRANGEMENT IN SC/ USC BOILERS:

Shop Welded Joints

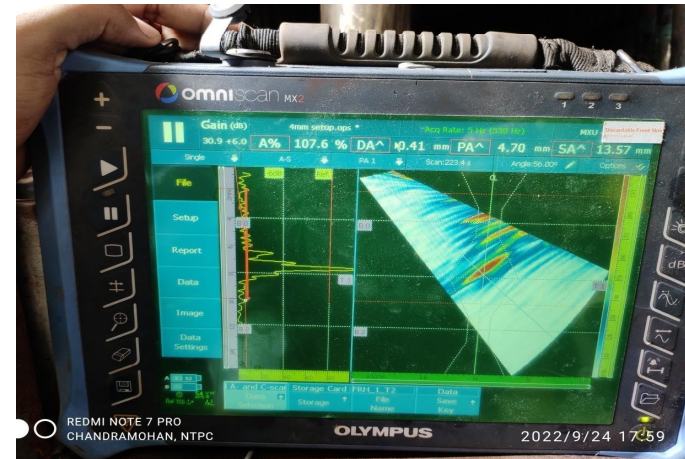
The weld joints and adjoining Heat Affected Zone (HAZ) were examined by Advanced NDE technique like Phased Array Ultrasonic Testing (PAUT) for detection of cracks on ID/OD of Super 304H tubes of FRH coils.

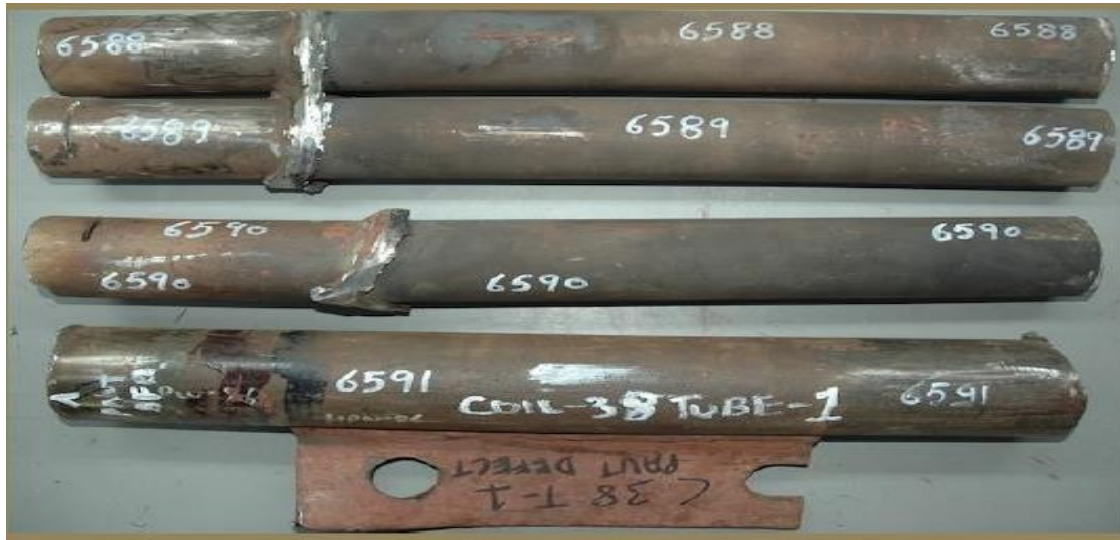
Table 1: Details of the sample

Seepage & pin hole leakage
No seepage & no defect in PAUT
 Seepage in Hydrotest
 Defect in PAUT in Lifting lug tube

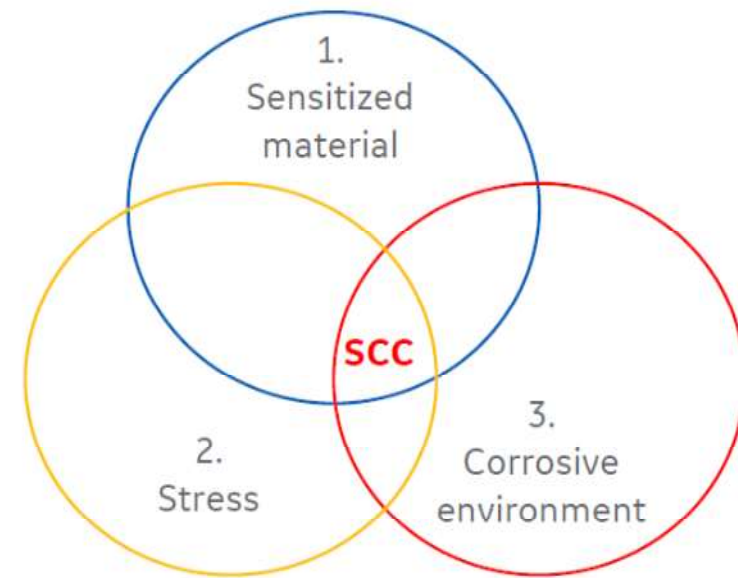
SCC failure mechanism

- **SCC in FRH & FSH coils** occurred due to presence of **Chloride deposits, Sensitized material & Residual stresses**
- **Sensitization and residual stresses cannot be avoided completely**
- **Chloride ingress may occur**
 - a) During Transport
 - b) During Hydro Test
 - c) At site during storage and erection
 - d) During Storage at manufacturer

Solution is to restrict exposure to chloride content

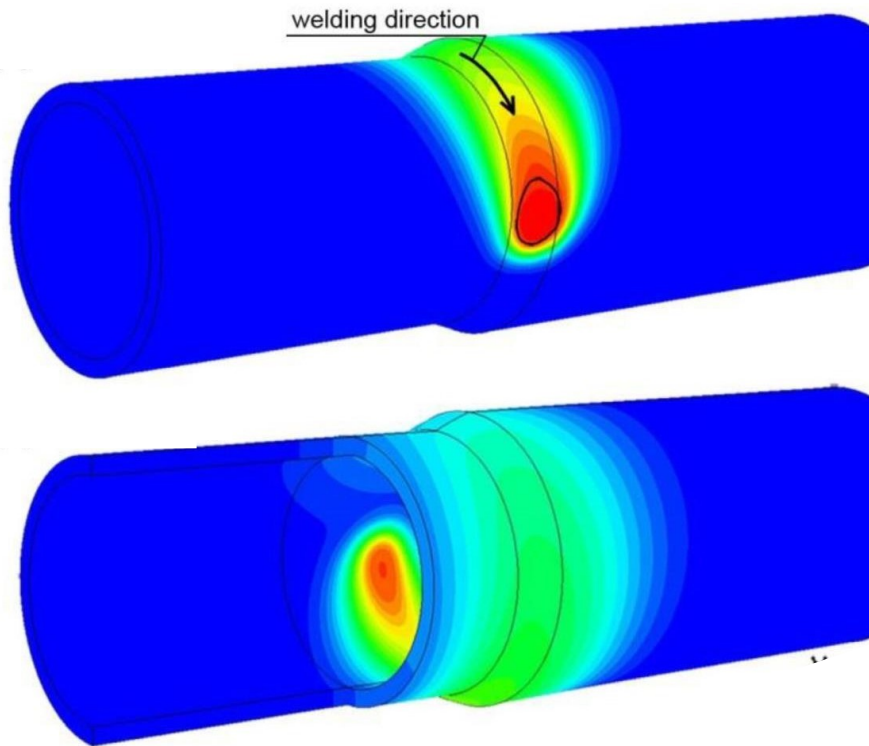
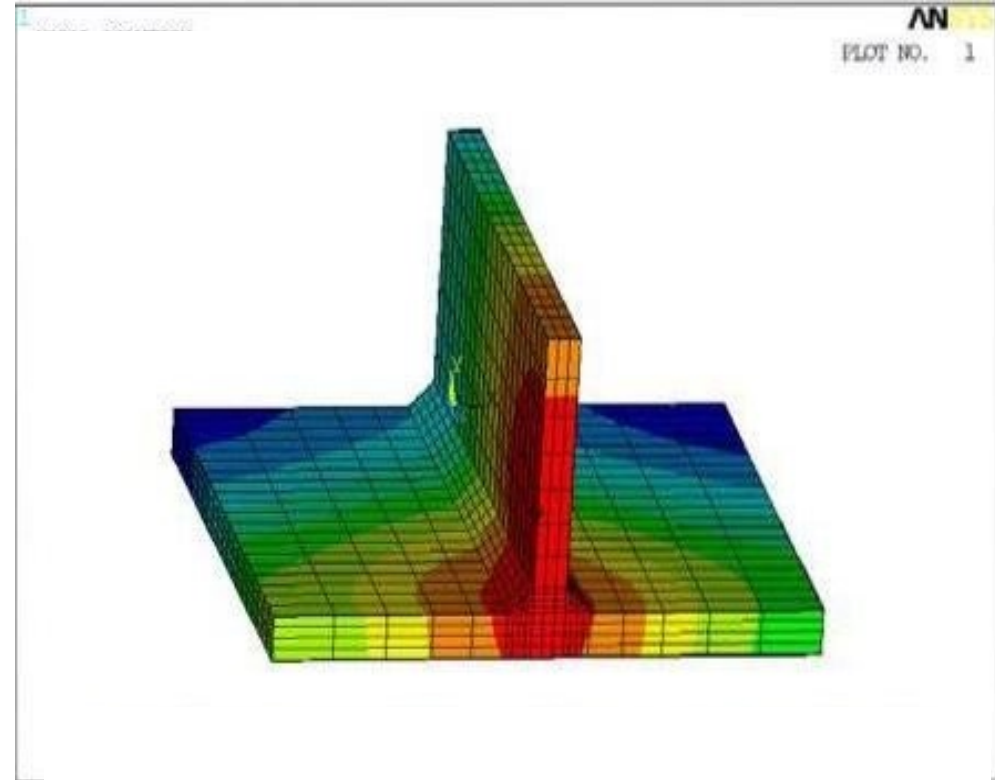
Stress Analysis of Weld joints

Stresses in Fillet joint is higher than in Butt weld joint

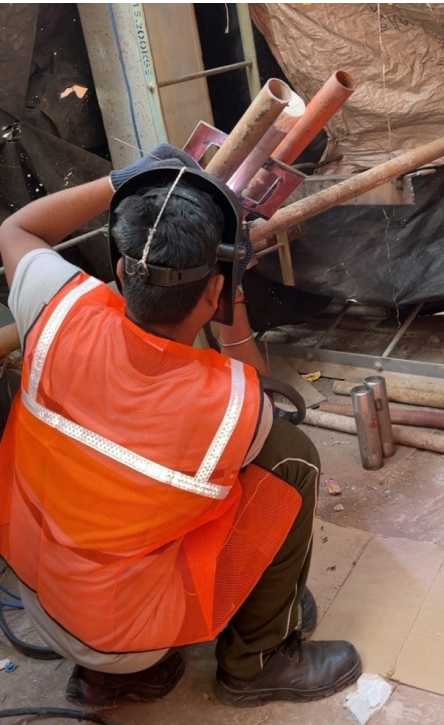
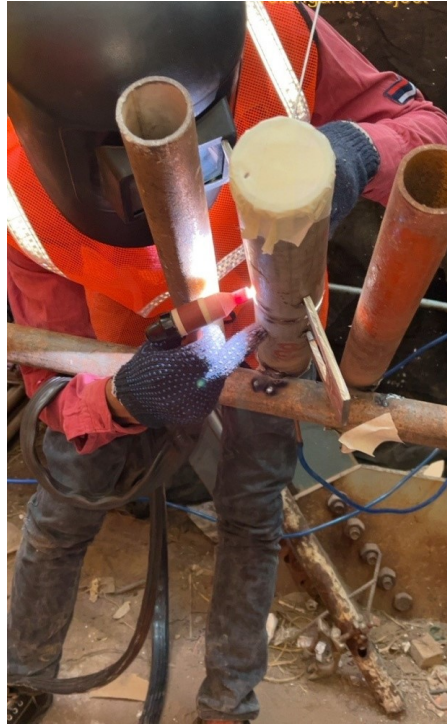
IBR welders are not giving desired quality at FRH location though Qualified in welder test

To minimise defect rate welders were trained on weld booth by simulating actual constraint conditions.

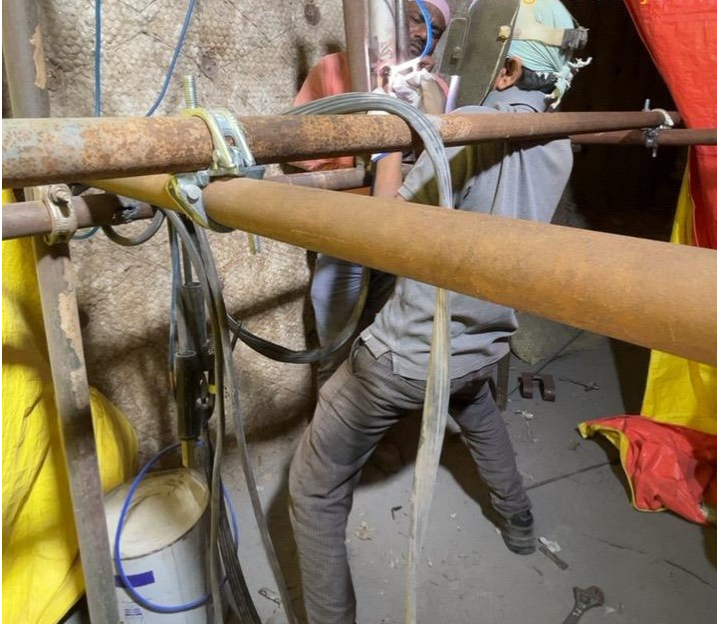
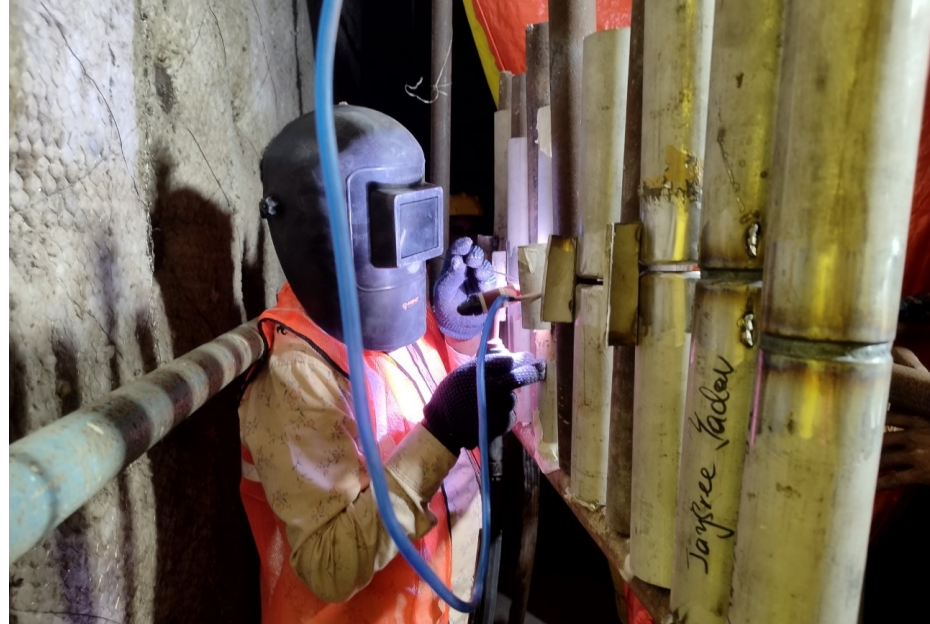
Welder Qualification in simulated condition

The extremely difficult approach to actual location of the weld joint imposes immense challenge to the welders to give defect free weld joint.

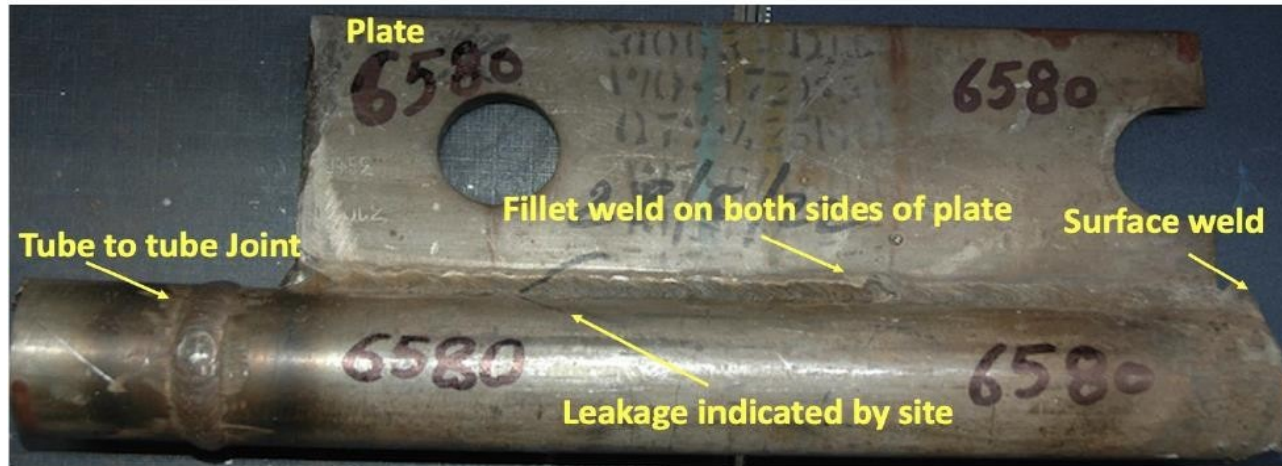
Failure Analysis of FSH sample at NTPC R&D lab

- Tube size: OD- 44.5 mm, thickness 8.1 mm
- Tube material: SA213 TP S30432 (Super 304H)
- One of the tube sample has been cut from the seal band crown plate weld location where seepage was observed in hydrotest
- Total FSH coils: 104 Nos.
