## Retrofitment of SEALGUARD ASSEMBLY in WAGON TIPPLER for reliable operation of movable Side

### A case study of NTPC Kudgi

**PRESENTED BY :** HIMANSHU KR , DGM (FHMM) – Main Author  
Manish Kumar Sah , AGM ( FHMM) - Co - Author

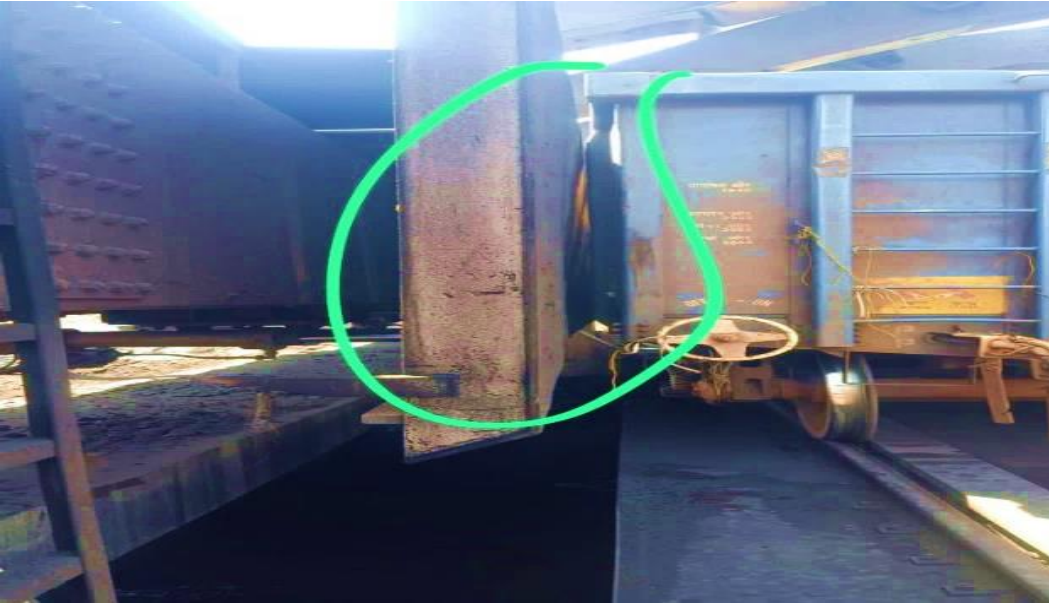
# PROBLEM STATEMENT – SIDE BEAM NOT TOUCHING WAGON PROPERLY

As per RDSO Guidelines  
consult the concerned zonal railway for this confirmation) suitable slots shall be provided in the side support beam, to permit the top clamping of the wagons] **There shall be metal to metal contact between the side support beam and the side stanchions of the wagon i.e. no rubber pad or any other alternative, shall be provided on the contact face of the side support beam**

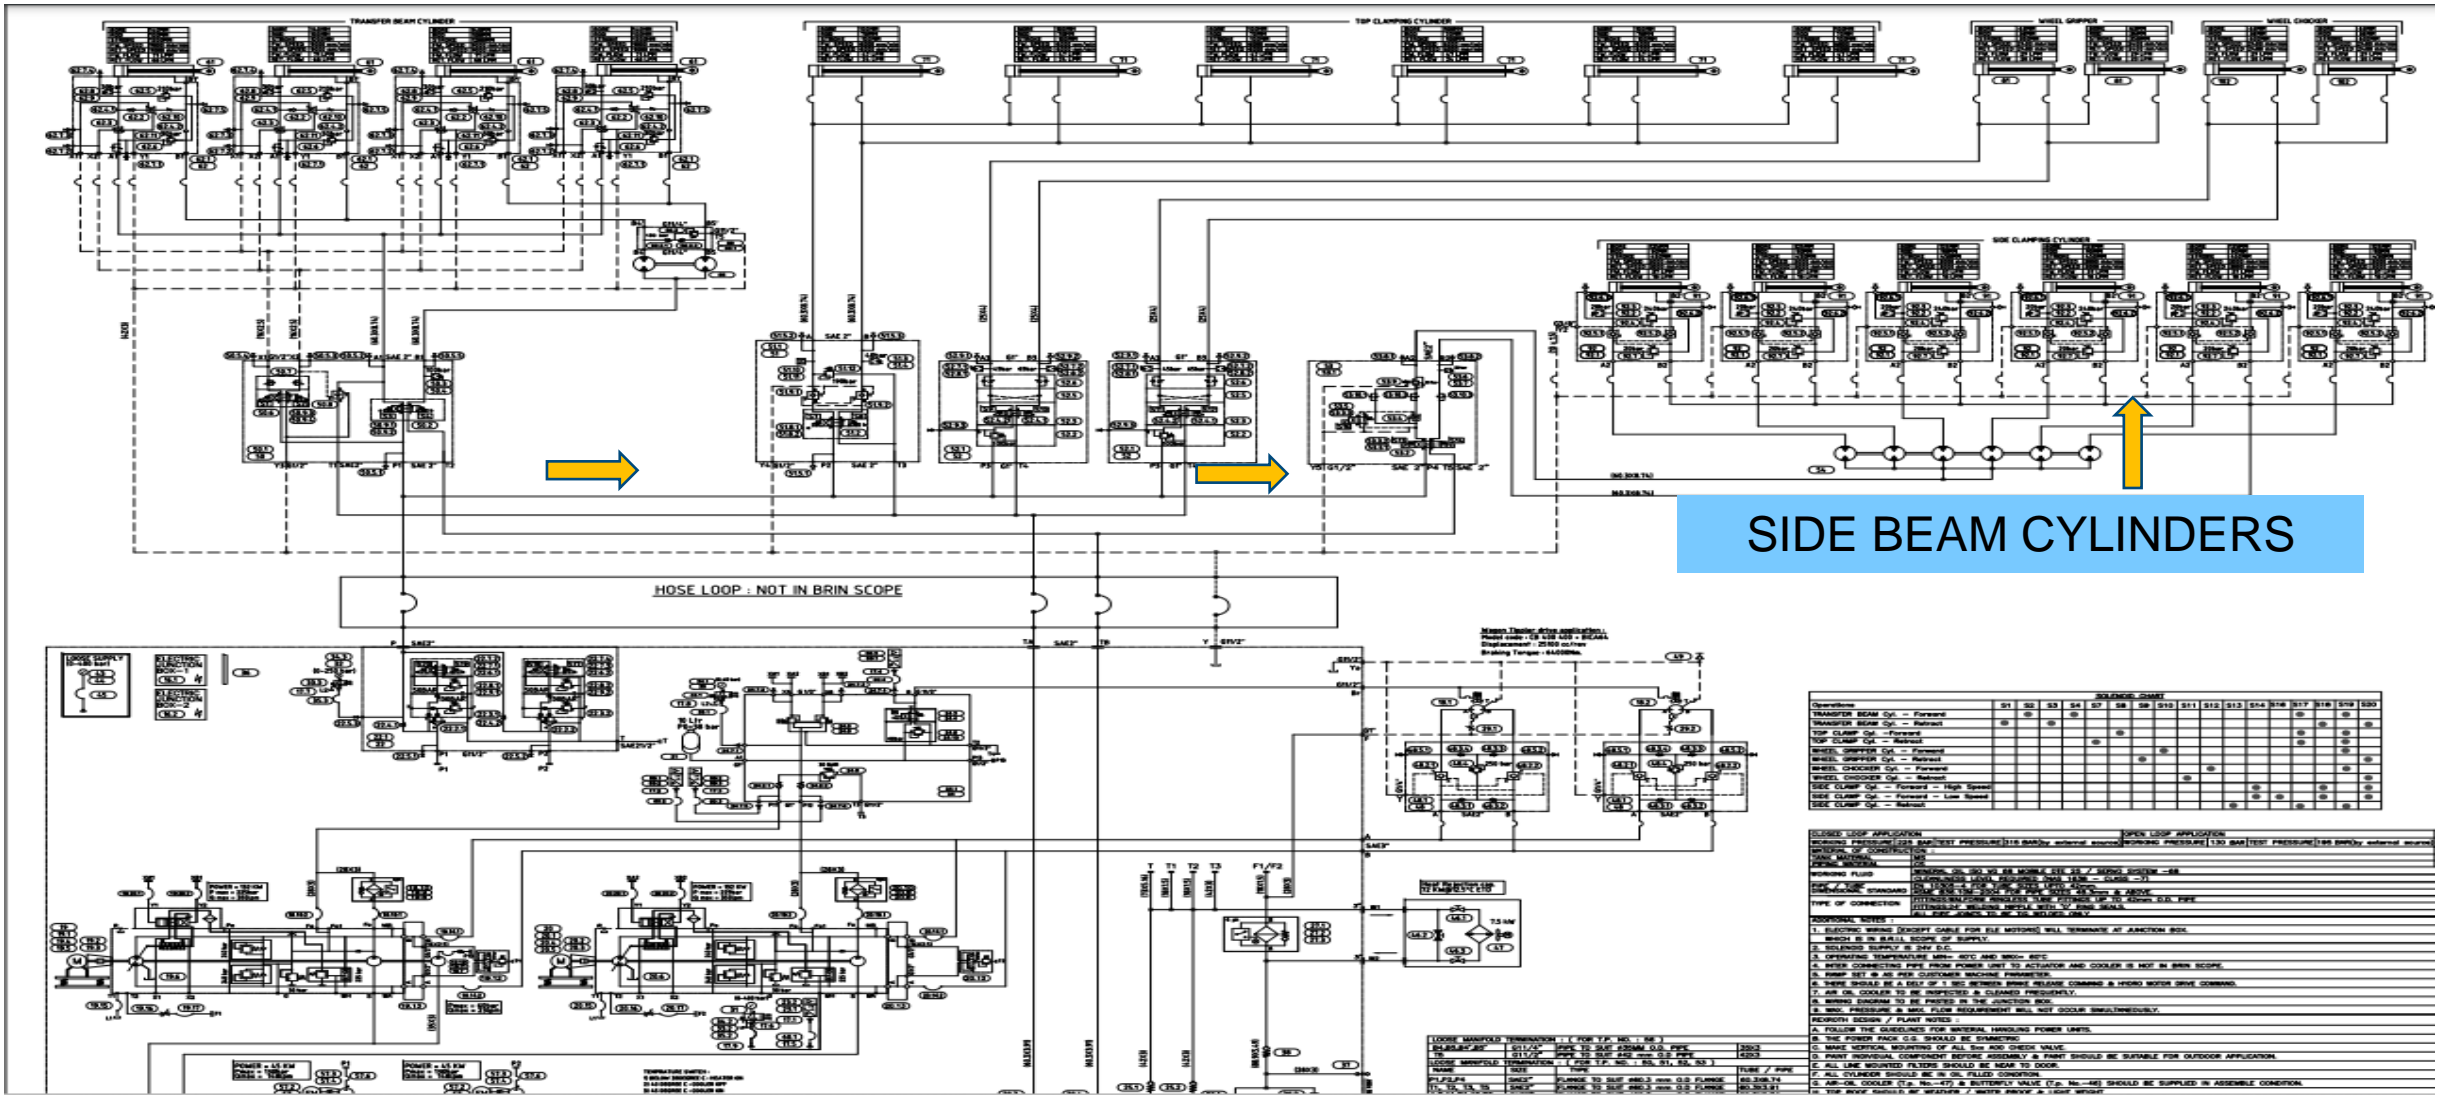
# HYD. CIRCUIT OF SIDE BEAM OPERATION

**SIDE BEAM CYLINDERS**

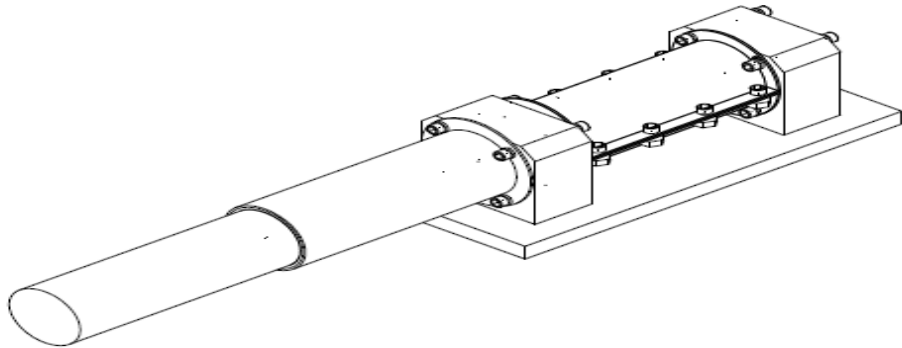
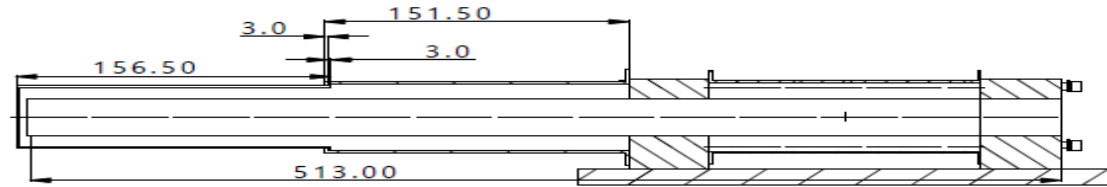
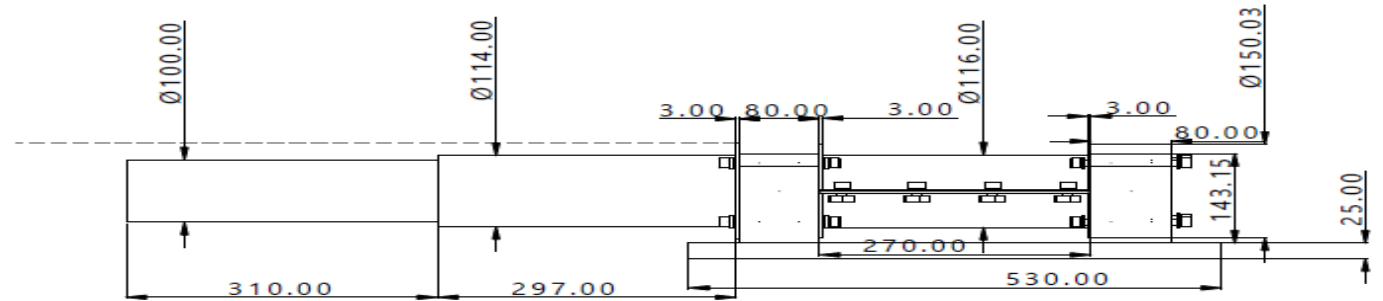
SECTION A-A

NOTE-THESE DIMENTIONS ARE APPROX WILL BE REVIEWED AS PER SITE DIMS

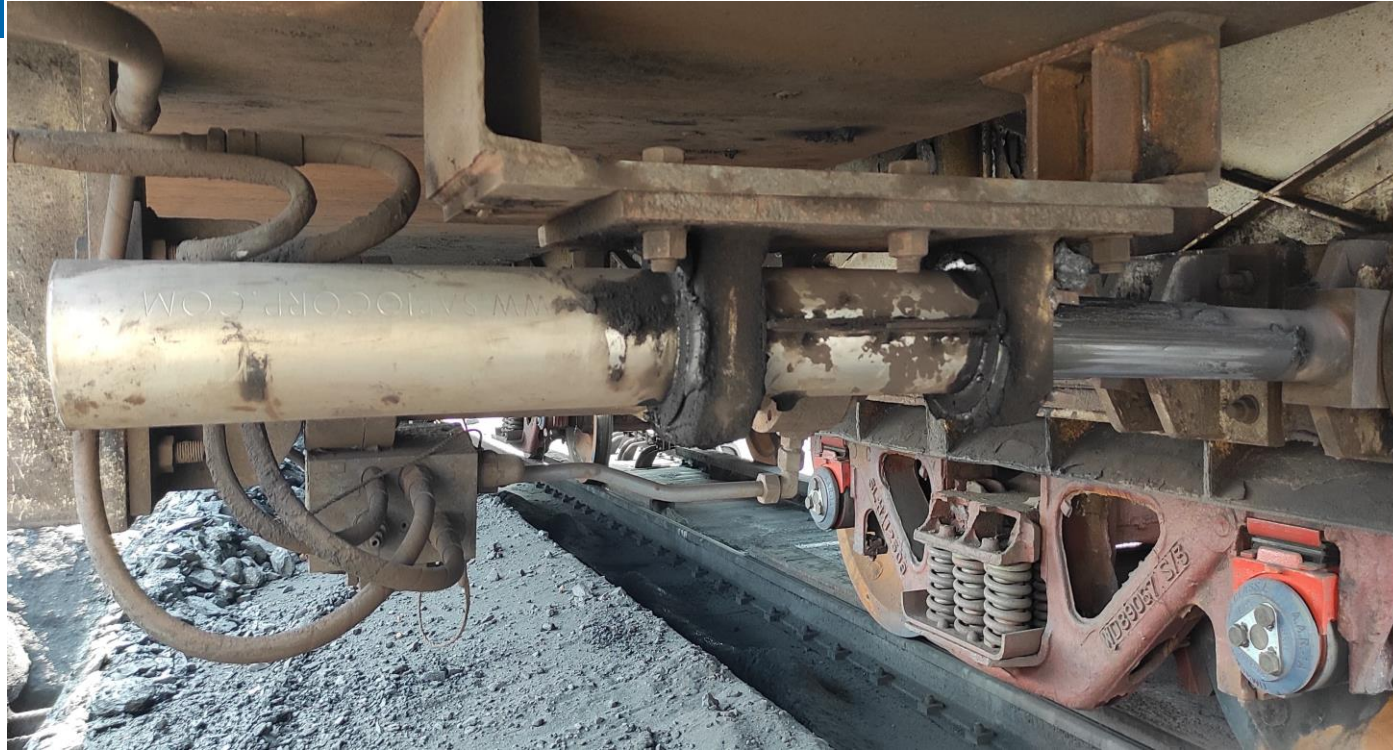
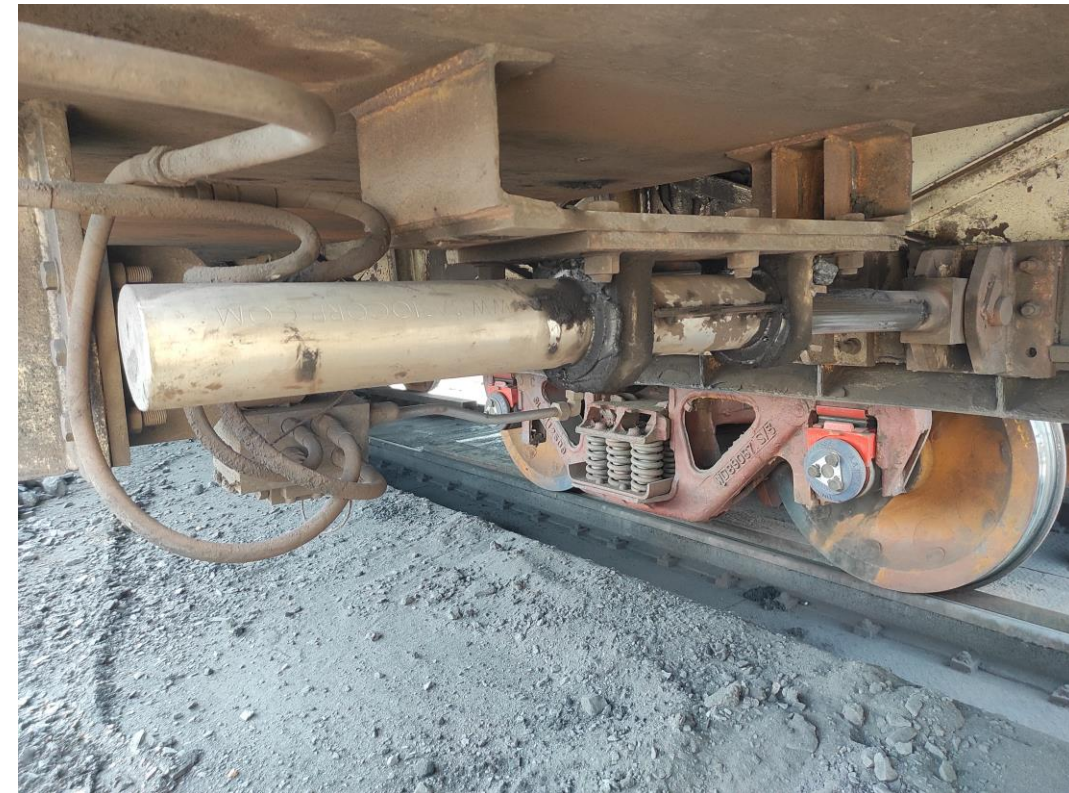
# FUNCTIONAL TESTING - AFTER FOUR MONTHS OF INSTALLATION

**SAFETY FACTOR = RISK X LIKELIHOOD OF OCCURRENCE.**  
SAFETY FACTOR reduced and repetitive maintenance eliminated.

- NO TIPLING INTERRUPTION DUE TO GUIDE ROD GREASING. No Problem of PU PAD FALLING
